# PEDDOCKS ISLAND

## Redevelopment Guide

**Scope:** The intention of this document is to catalog the existing historic structures on Peddocks Island and guide their compatible adaptive reuse. The introductory section provides contextual information on the island as a cultural and recreation resource. The later sections catalog existing buildings, focusing on their structural condition, historic integrity, and remaining hazardous materials.

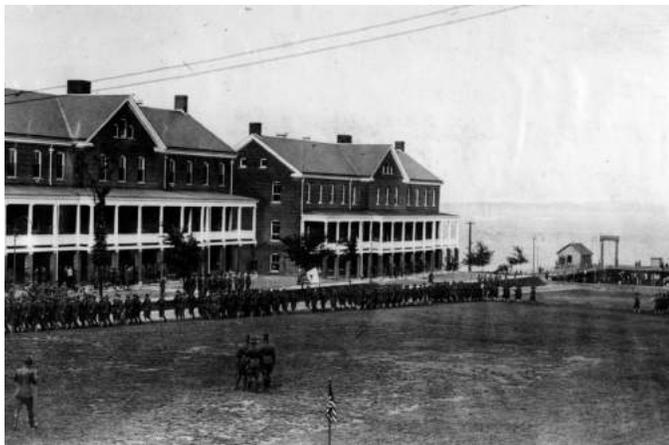
View of demolished Barracks adjacent to Building 10..

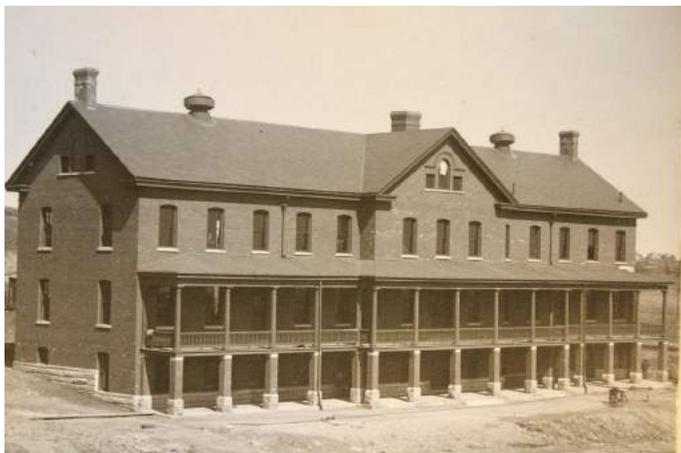
Covered porch Building 11, S. elevation.

**Brick and stonework:** Minor repointing. Repair to crack above one window. Three porch columns need rebuilding and porch slab needs significant restoration.

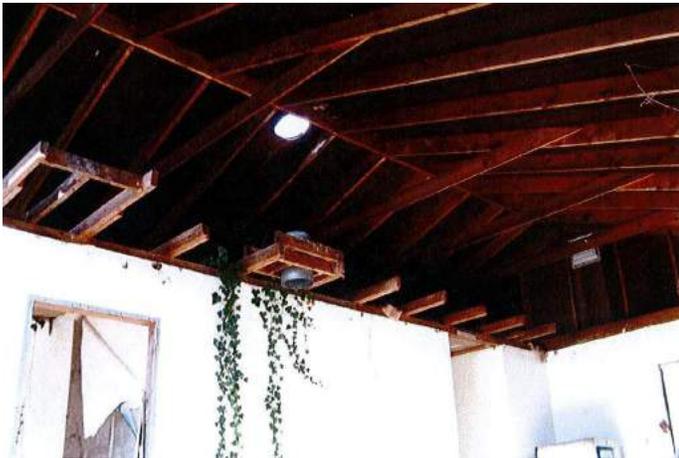
Interior of Cottage 09 showing cut back joists.

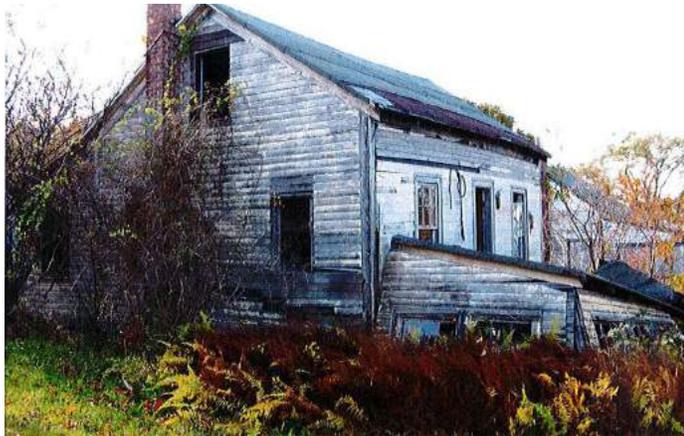
Collapsed front porch to Cottage 21.

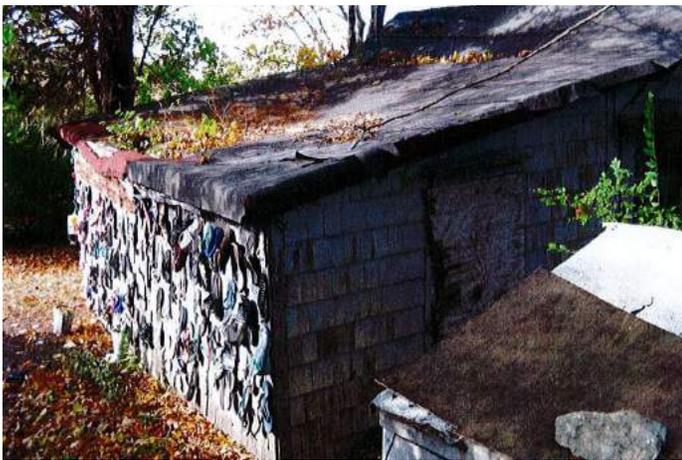
SE view of Cottage 30 showing roof condition.

**Roof and gutters:** Roll asphalt is in varying states of decay.

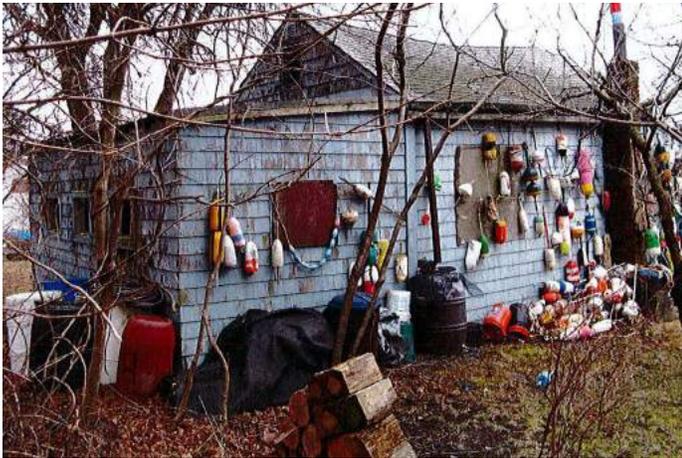
Rear extension Cottage 32.

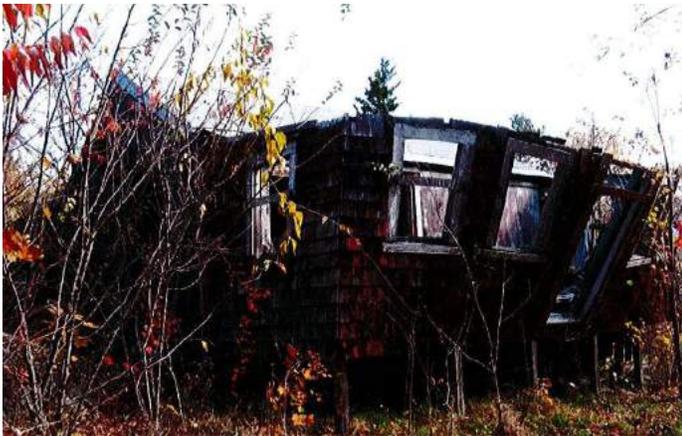
Collapsed front porch, Cottage 38.

**Structural stability:** Main structure stable. Rear addition needs attention and front porch roof is missing threatening failure of the exterior walls..

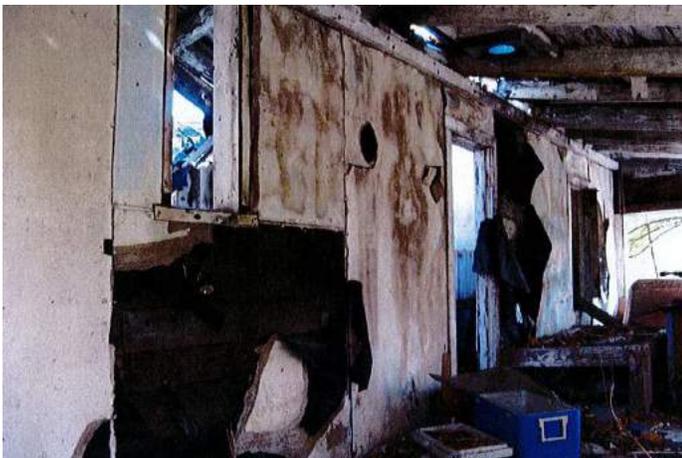
Interior condition of front porch, Cottage 39.

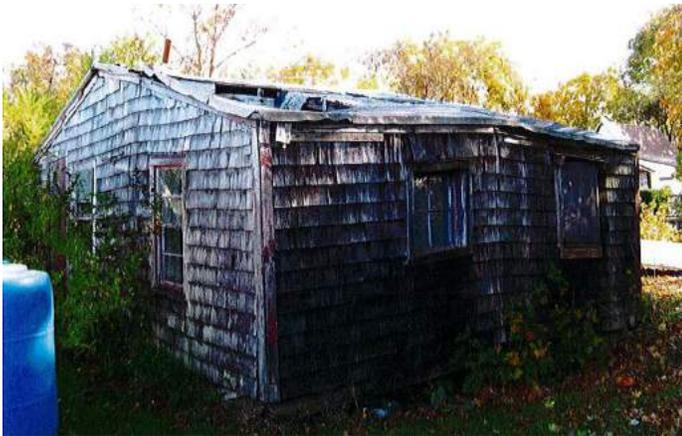
Collapsed roof, Cottage 39.

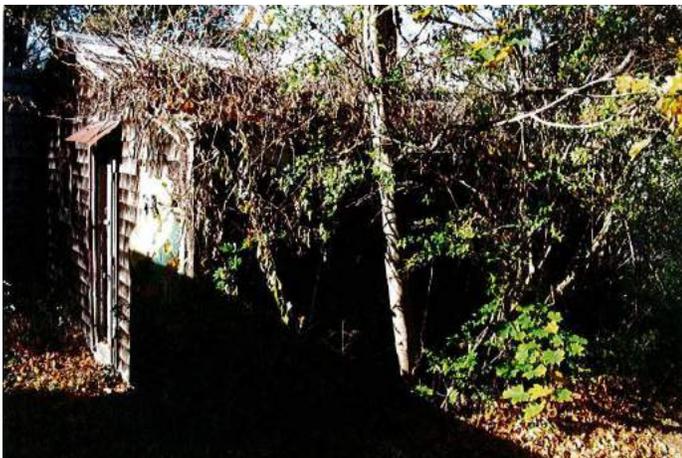
Overgrown condition of Cottage 39, SE corner.

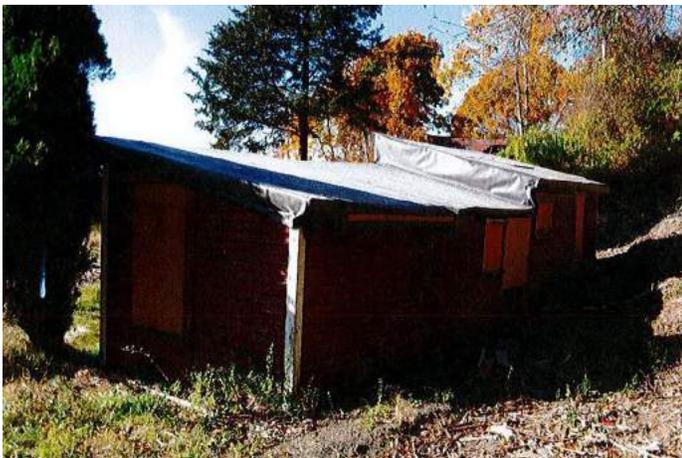
Temporary roof sheathing, Cottage 45.

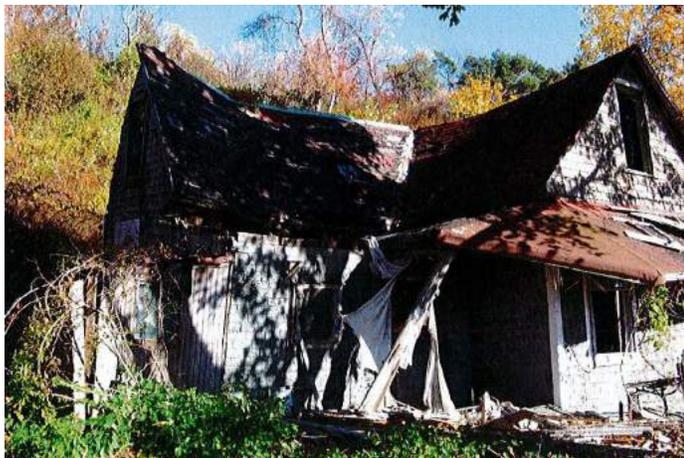
Deteriorated state of Cottage 46.
