National Park Service
Cultural Landscapes Inventory
2018

Peddocks Island
Boston Harbor Islands National Recreation Area
Park Review Draft: 05/17/2018

Cultural Landscape Inventory Name	Peddocks Island
Cultural Landscape Inventory Number	650138
Parent Cultural Landscape Inventory Name	Peddocks Island
Parent Cultural Landscape Inventory Number	650138
Park Name	Boston Harbor Islands National Recreation Area
Park Alpha Code	BOHA
Park Org Code	1727
Property Level	Landscape

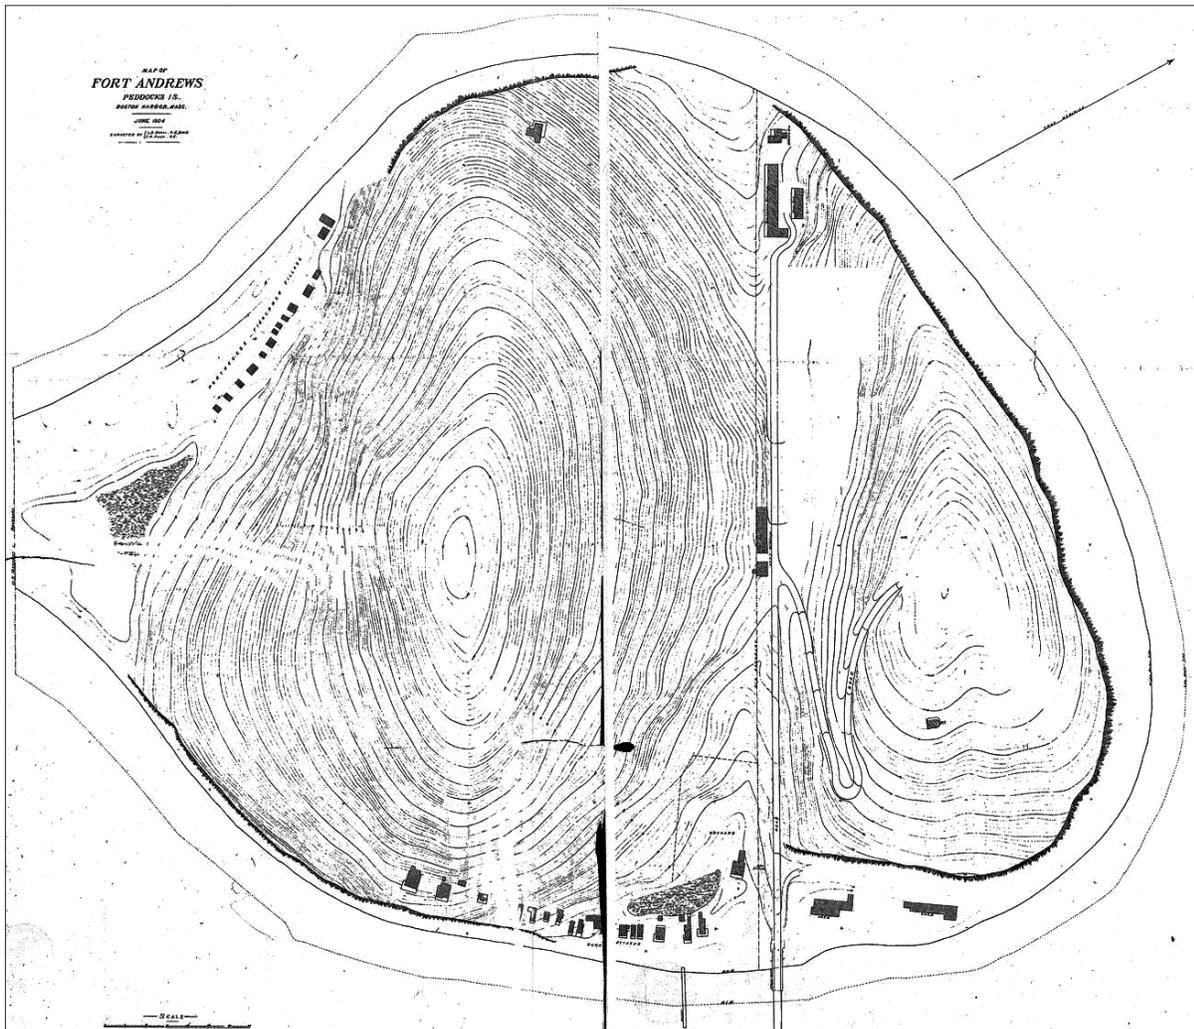
Figure 6. Map of Fort Andrews, 1904, before the fort expanded. The Cleverly Farm and summer cottages line the eastern shore of East Head while Portuguese fishing cottages line the southwest side. (Department of Conservation and Recreation--hereafter DCR--2009: 31)

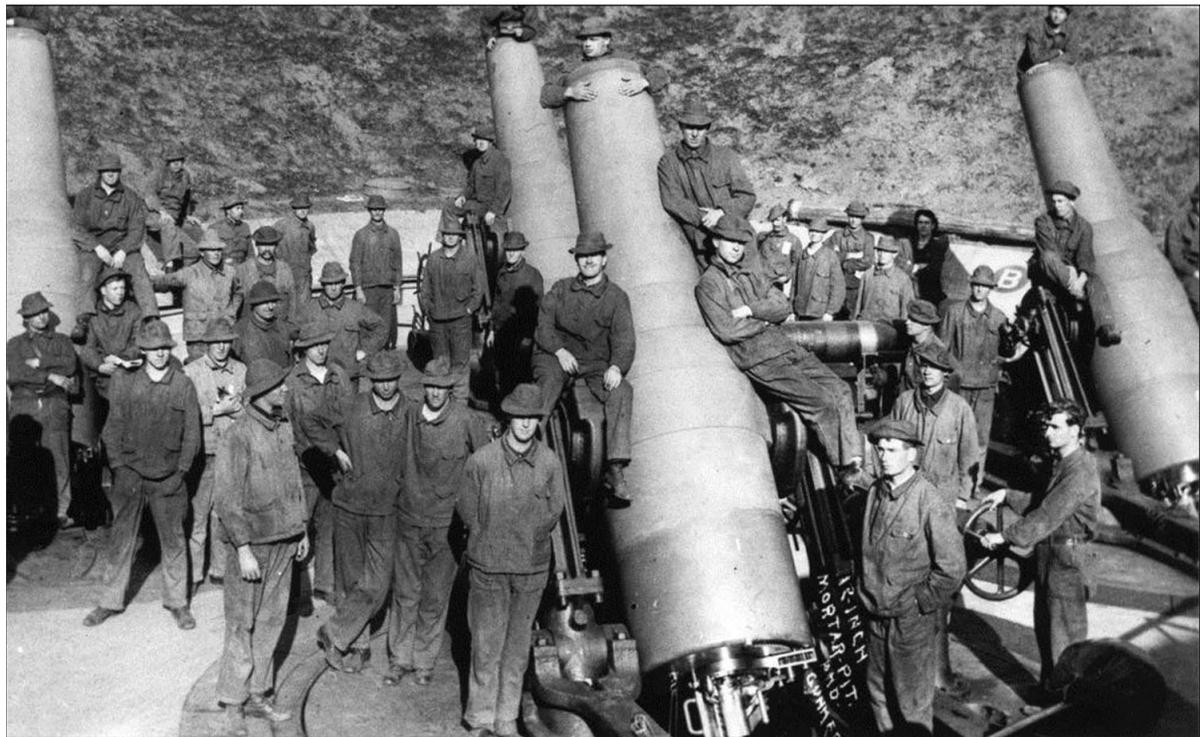
Figure 8. The 12-inch mortars in Battery Whitman, c.1910. (DCR 2009: 45)

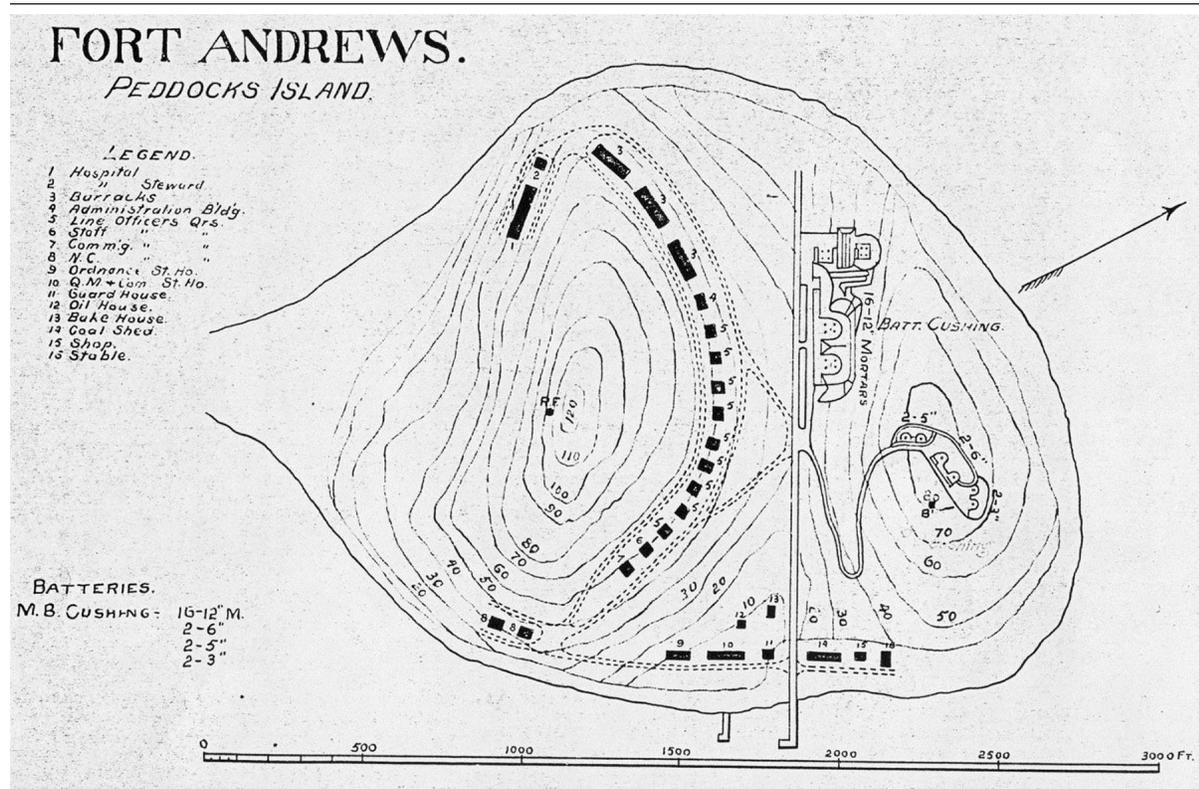
Figure 9. A 1903-04 plan for Fort Andrews, which aligned the various quartermaster buildings around the wharf along the eastern shore, and relocated the barracks, officers quarters, and the hospital around the south drumlin. (DCR 2009: 32)

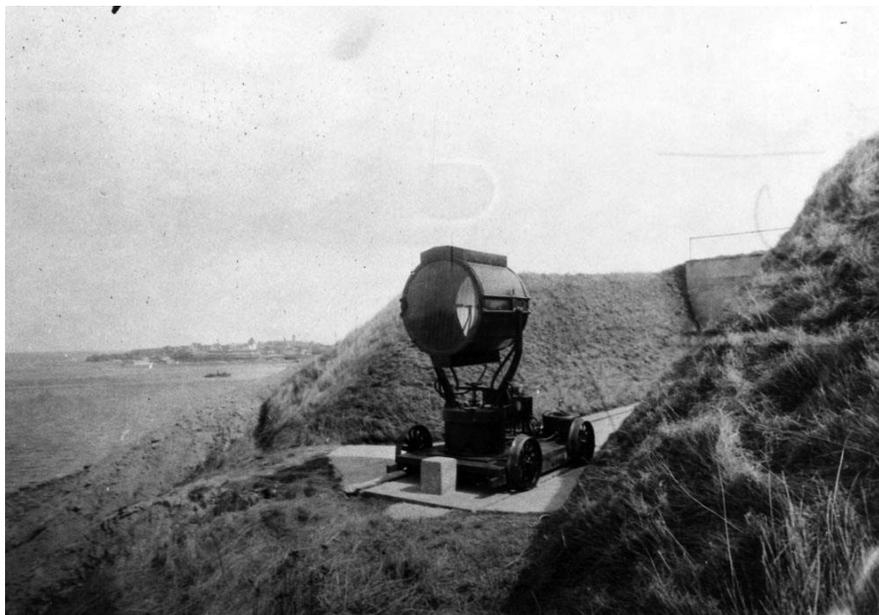
Figure 12. Photograph of the “gully” searchlight on the north slope of the north drumlin on East Head, c.1945. (DCR 2009: 66)

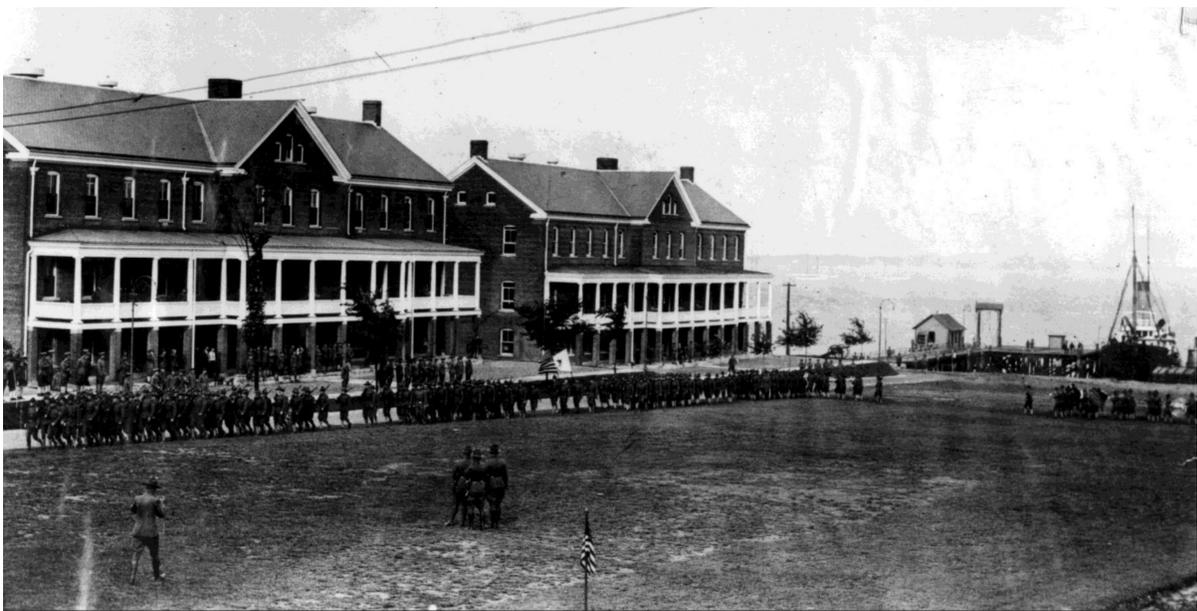
Figure 13. View looking northeast at barracks (#s 13,29) on the north side of the parade ground, after 1908. Note the maples in front of the barracks, graded and grassed parade ground, and light standards. (DCR 2009: 48)

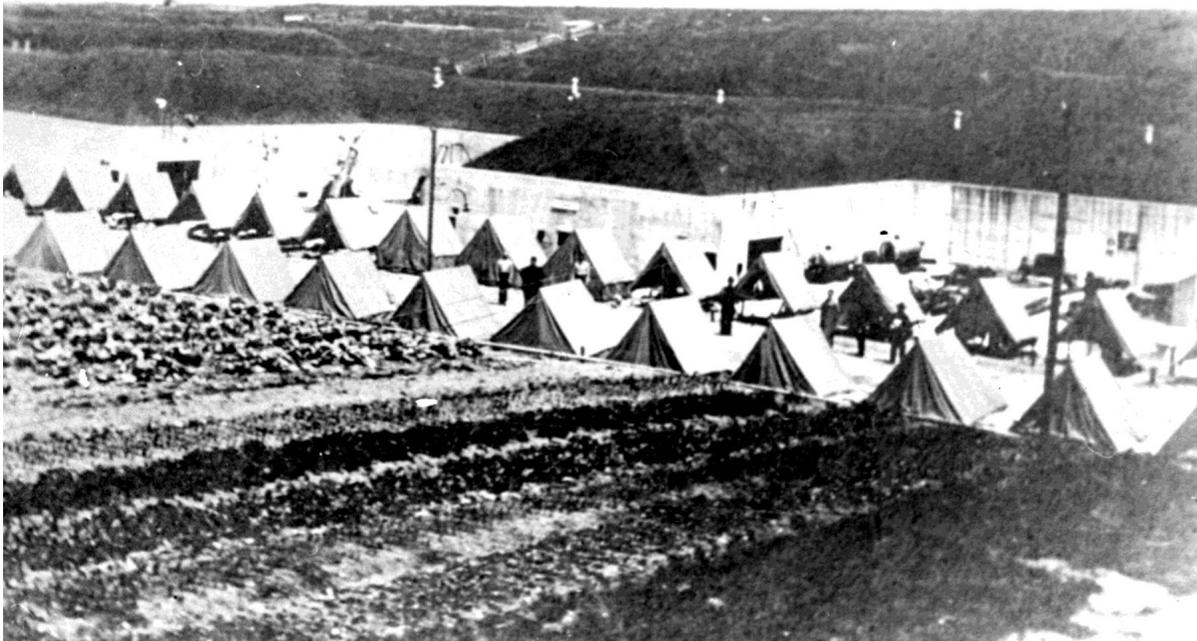
Figure 16. View looking north towards Battery Cushing in c.1915. Note the garden furrows in foreground, utility poles, and grass-covered battery. (DCR 2009: 47)

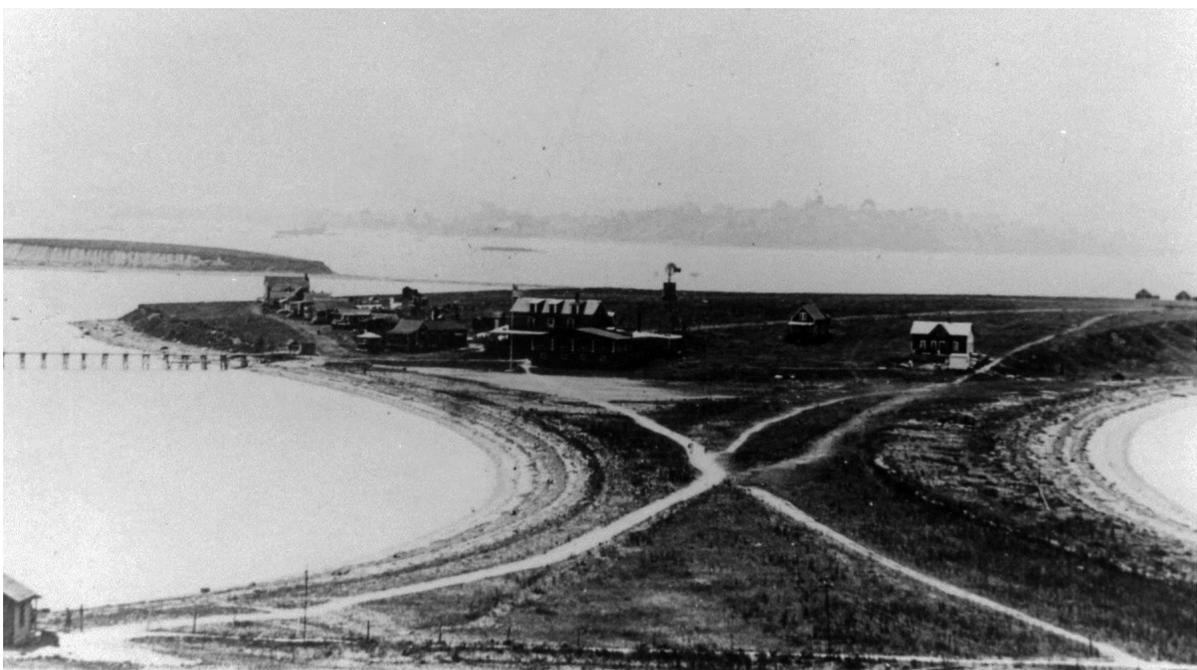
Figure 17. Middle Head as viewed from East Head, c.1910, looking south at summer cottages and the Island Inn. A windmill provides well water. Crab Alley can be seen in the background at image right, over the treeless drumlin. (DCR 2009: 44)

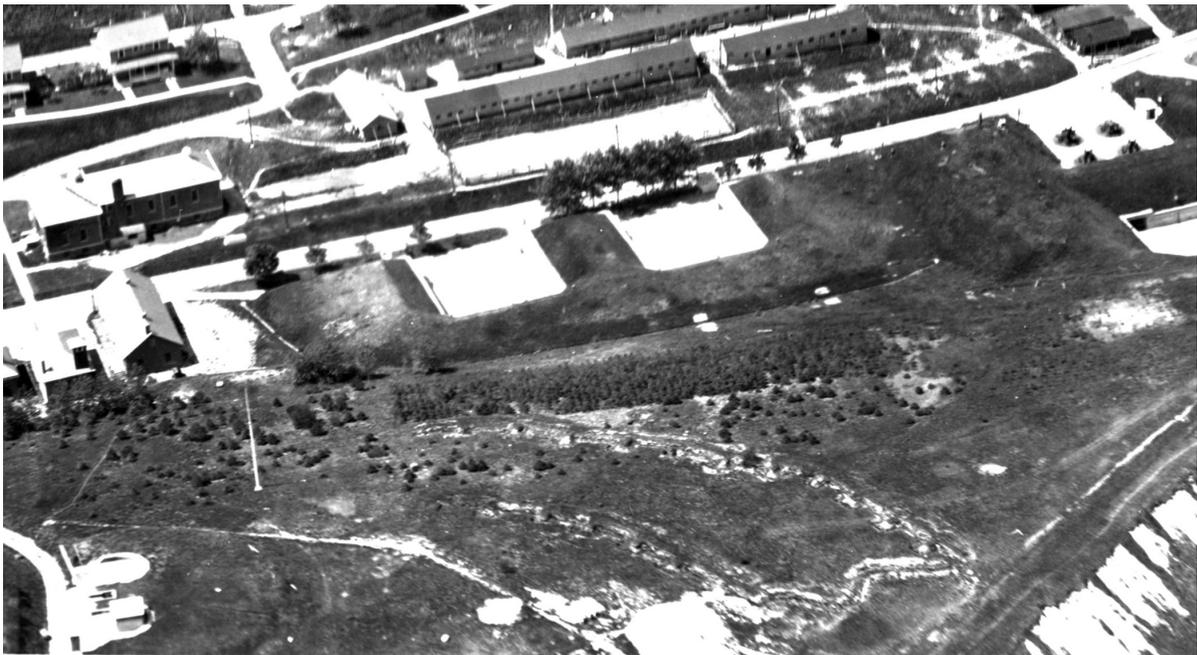
Figure 18. Detail of a c.1925 oblique aerial looking southwest at the zig-zag earthen trenches and orchard or garden areas on the west slope of the north drumlin. Note the temporary buildings across from Batteries Cushing and Whitman. (BOHA Archives, #B17170010)

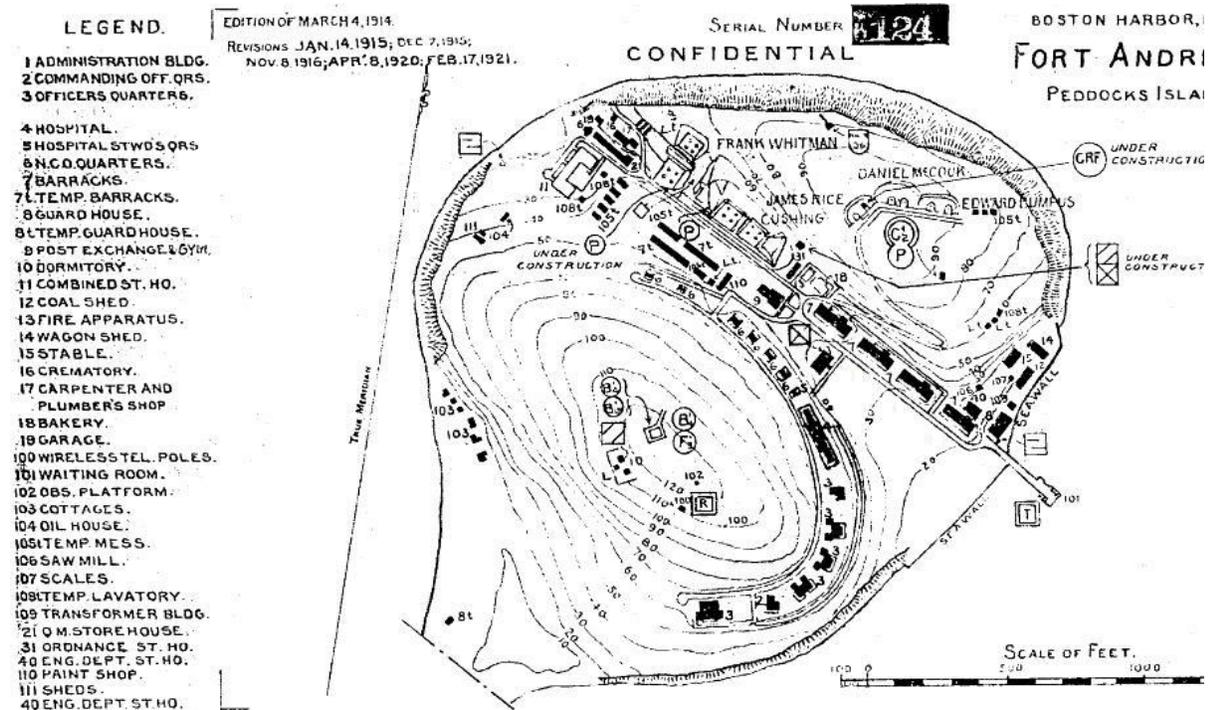
Figure 19. Plan of Fort Andrews, 1921. (BOHA Archives, #B17170010)

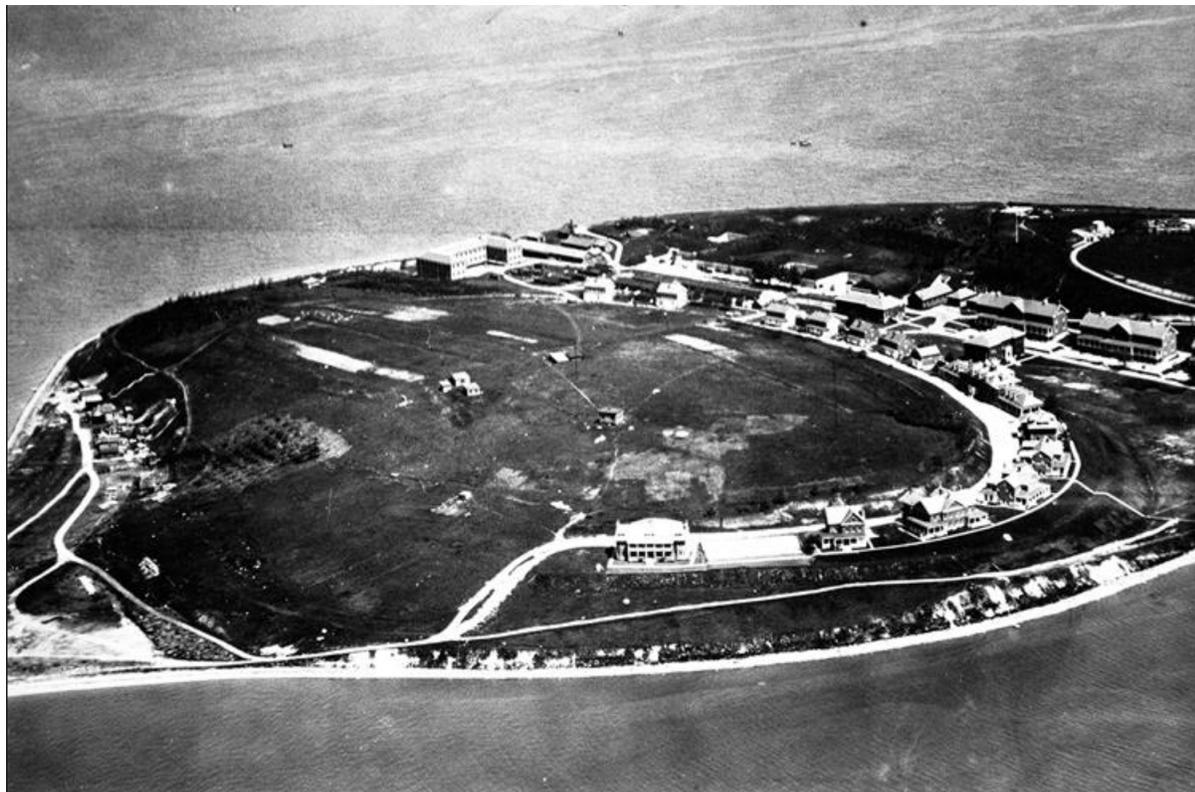
Figure 20. A 1925 aerial of East Head from the southeast showing the facilities at Fort Andrews as well as the group of former fisherman cottages known as Sergeants' Row" and orchard on the west side. (DCR 2009: 55)

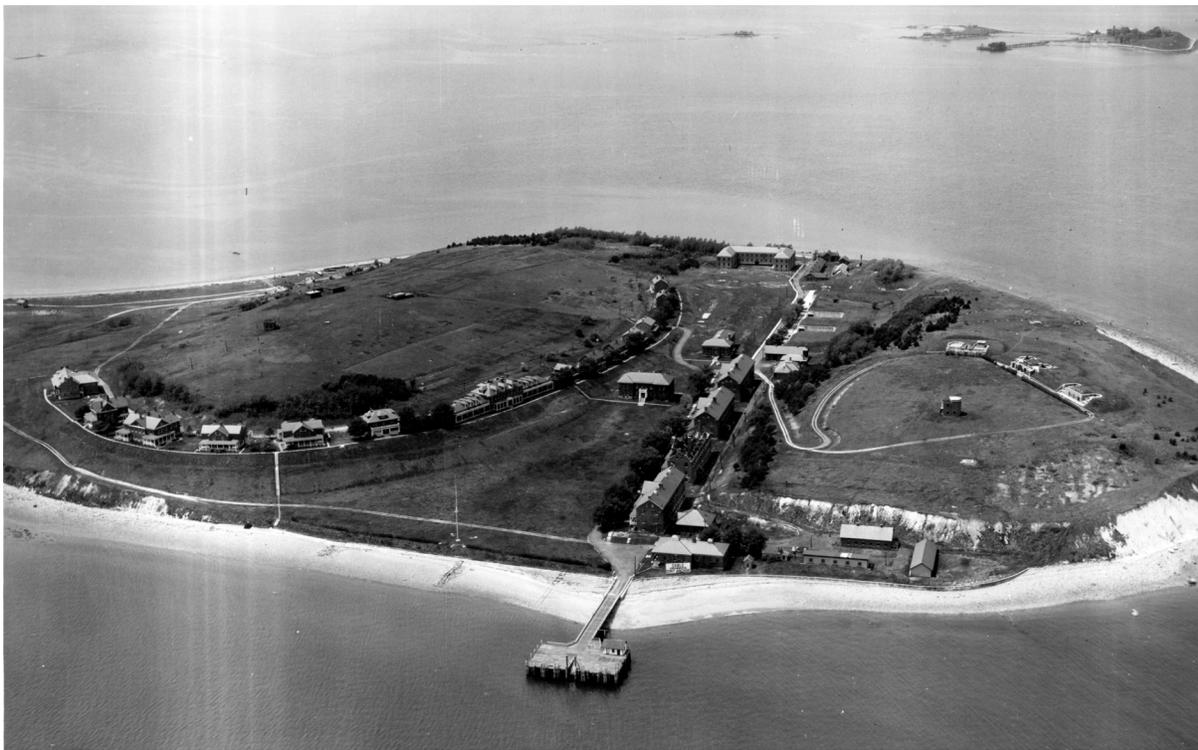
Figure 21. A 1932 aerial of East Head from the northeast, showing the burned remains of barracks (#13). Note the mature trees fronting the four barracks. (DCR 2009: 56)

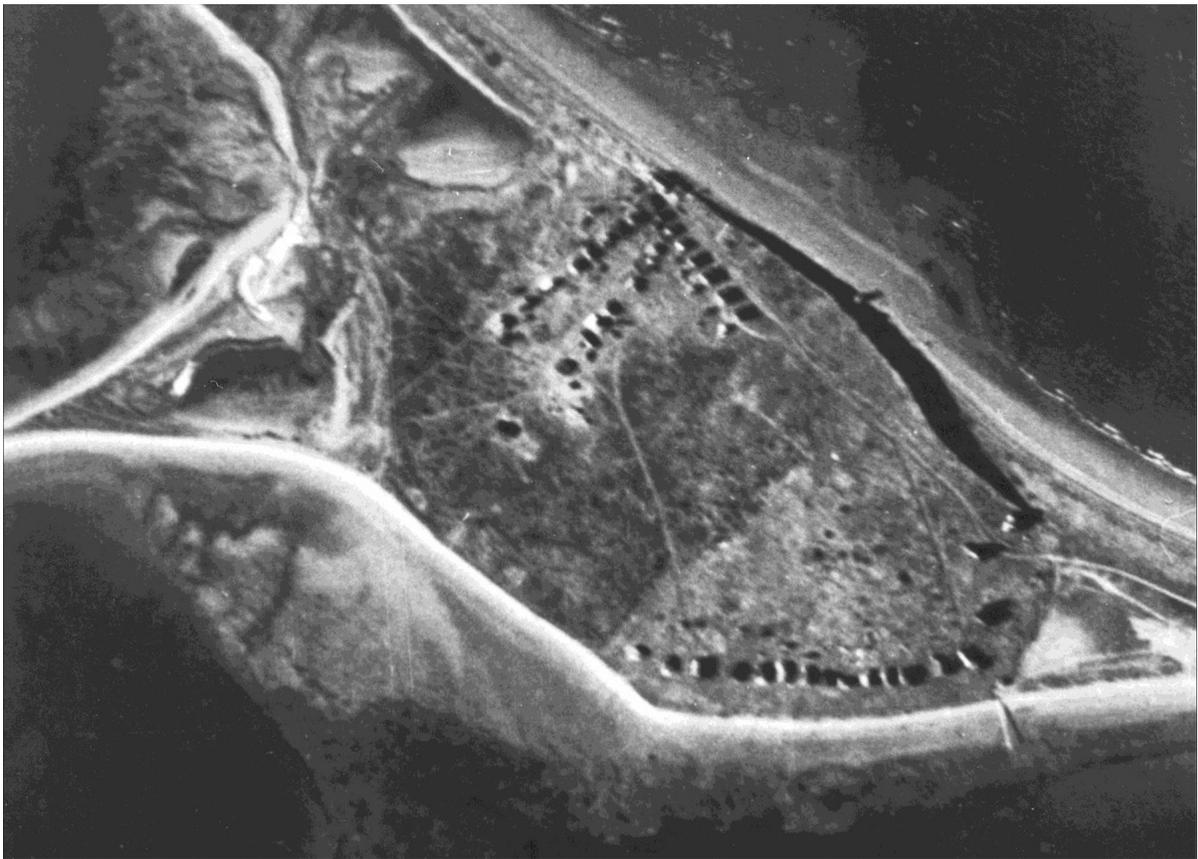
Figure 22. Aerial photograph of Middle Head, c.1938, showing nearly all the cottages on the island, with low groundcover and dirt paths throughout. (DCR 2009: 57)

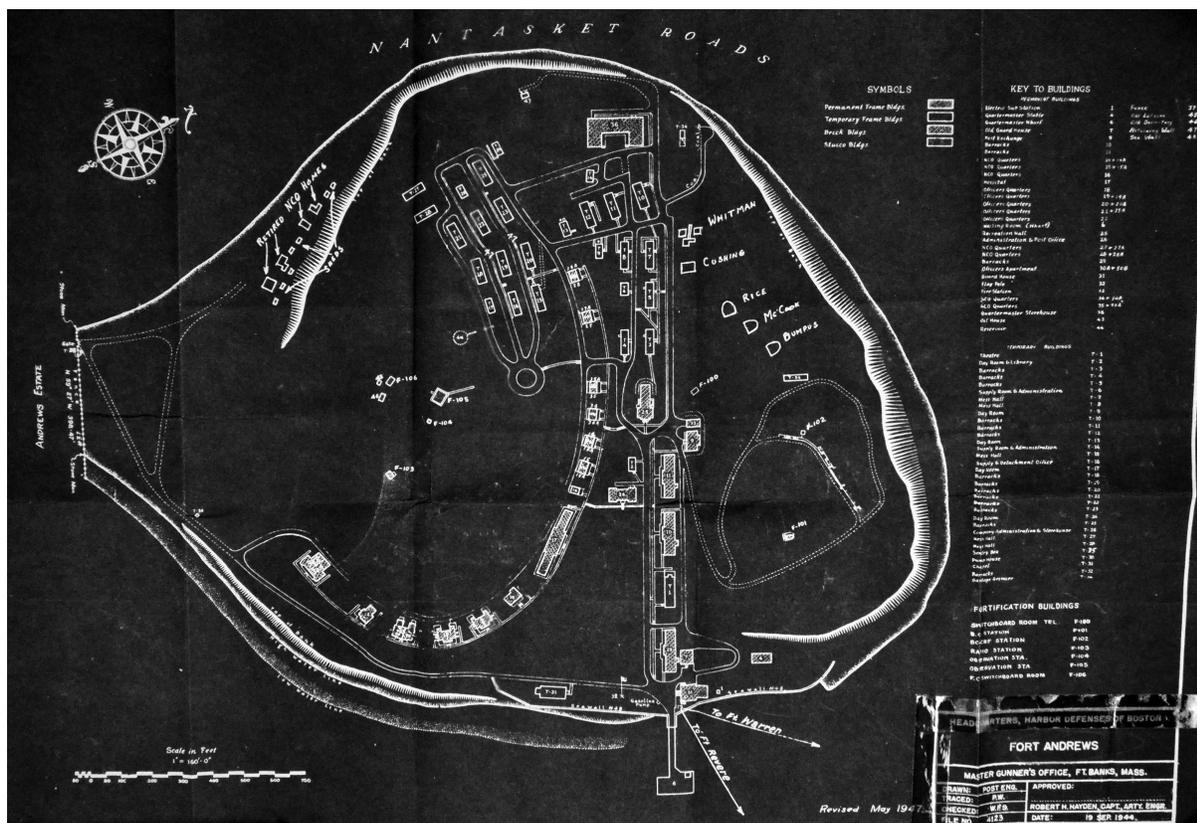
Figure 23. Plan of Fort Andrews, 1947. (DCR 2009: 67)

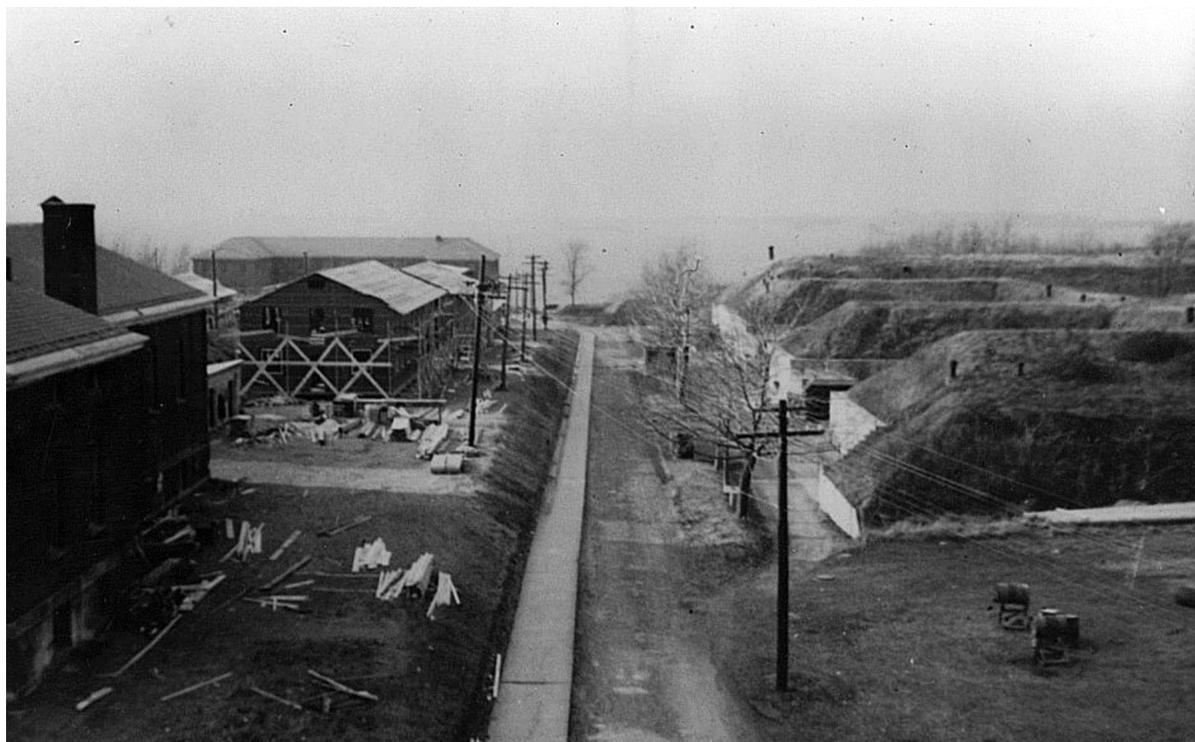
Figure 24. View looking northwest in 1940 and construction of new temporary barracks in preparation for World War II. Batteries Cushing and Whitman are at image right and the post exchange/recreation hall (#25) is at image left. (J.K. Kurnsey, from DCR 2009: 58)

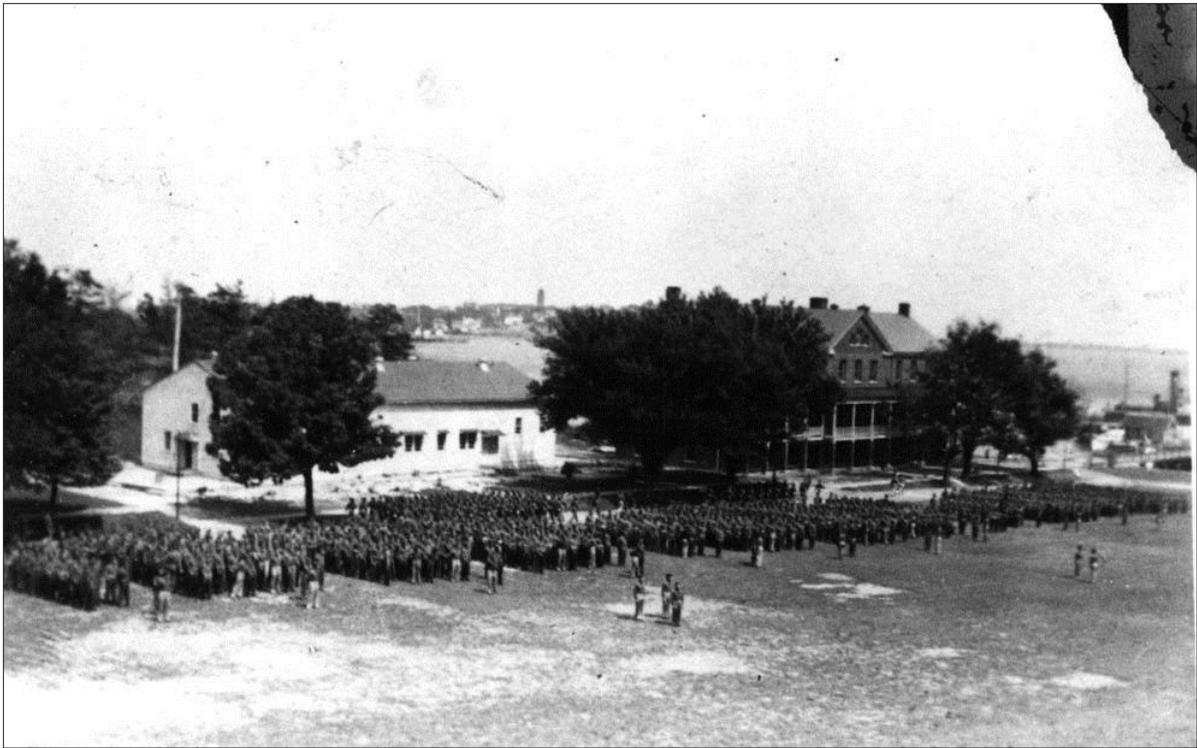
Figure 25. View looking northeast from Officers' Row in 1945 at the parade ground, theatre building (#T-1) at the former site of barracks (#13), and barracks (#29). Note the size of the maple trees. (DCR 2009: 64)

- Fire Station (#33): 1-story brick, hipped slate roof, concrete slab foundation, 25x44 feet. Used for storage. (Figure 25).
- Quartermaster's Storehouse (#36): 2-story brick, hipped slate roof, brick foundation with full basement, central hyphen 172x36 feet, two wings 36x49 feet. Vacant.

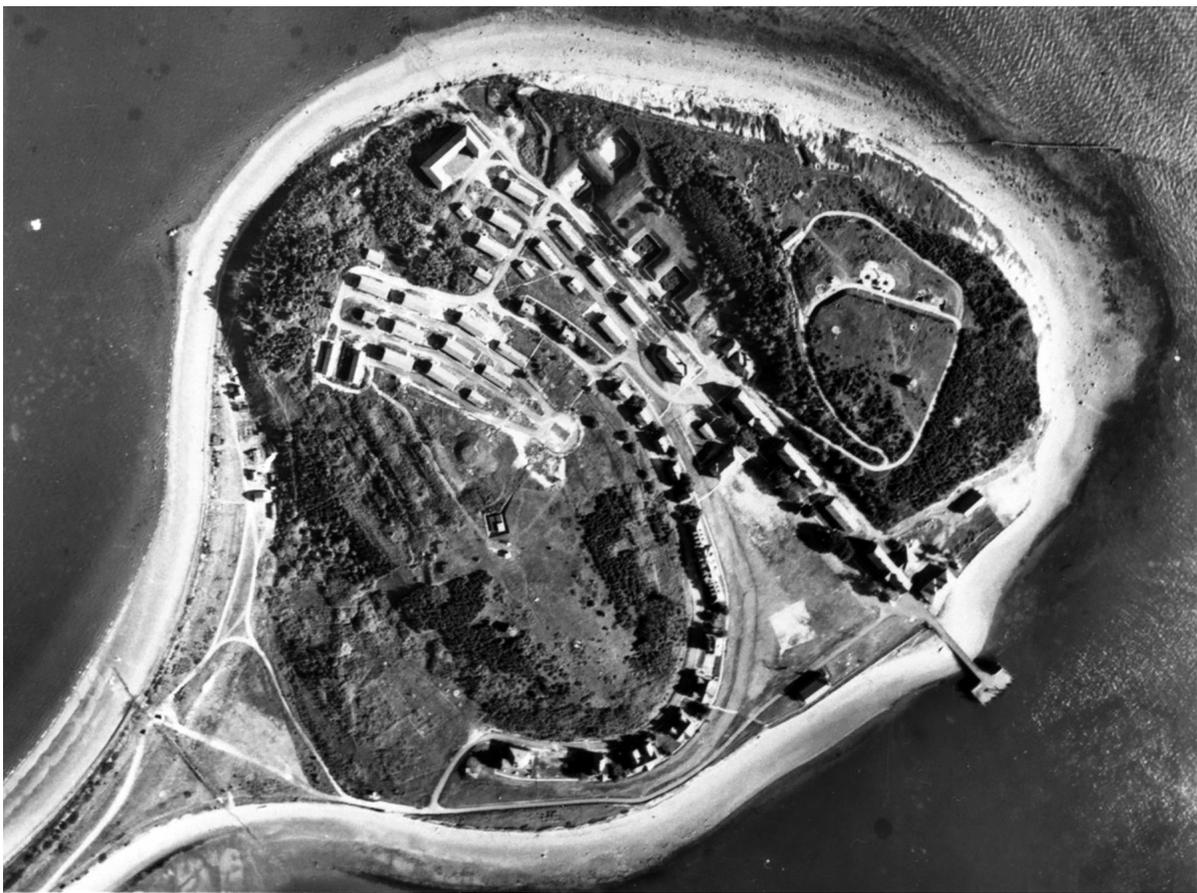
Figure 27. Aerial view of East Head from 1944, showing World War II-era additions. Note the partially complete forest succession and baseball diamond on the parade ground. (DCR 2009: 65)

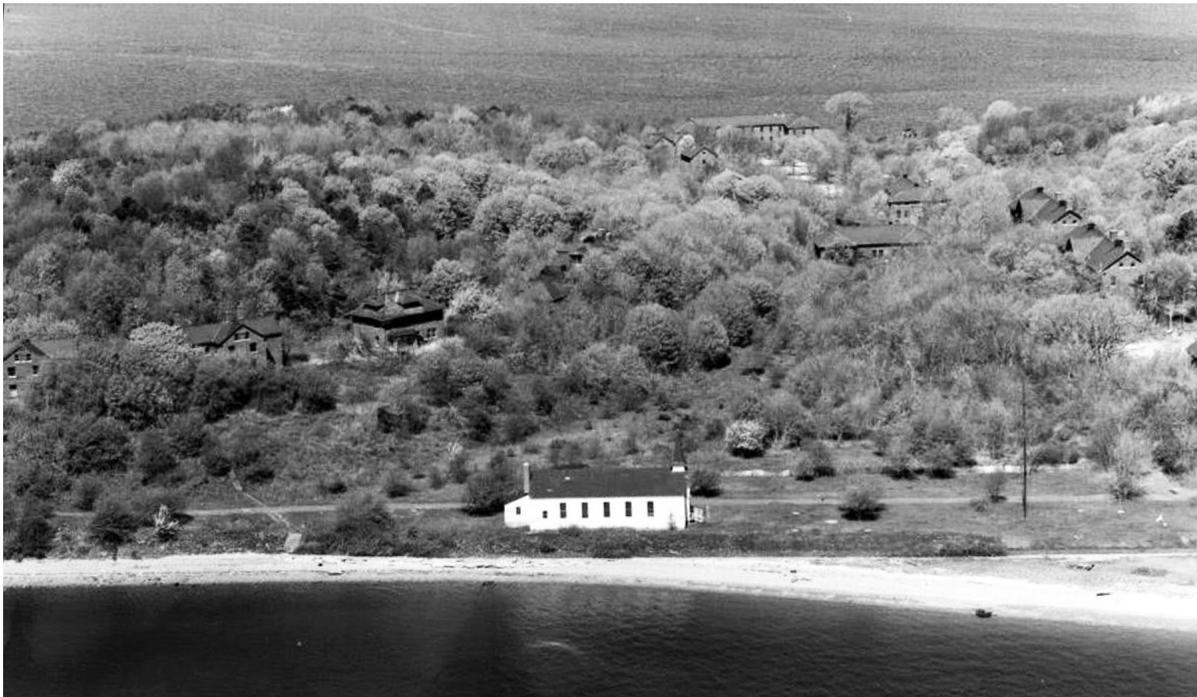
Figure 28. Oblique view looking west at the chapel (T-31), c.1971, and the overgrown parade ground. Note the total forest succession amongst the buildings and surrounding hillsides. (DCR 2009: 69)

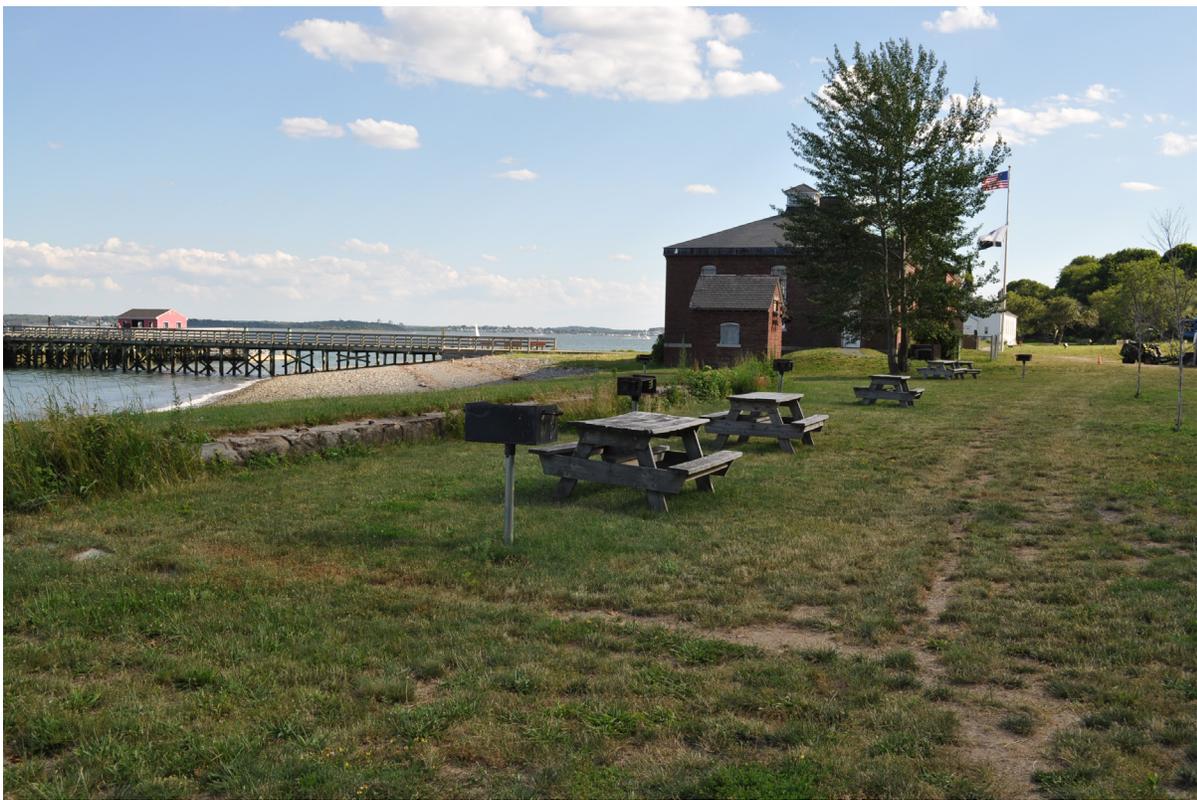
Figure 33. One of the island’s picnic areas is located north of the new guardhouse (#31) and electric substation (#1), alongside remnant foundation wall of the coal shed. View looking south. (OCLP 2017, DSC-0843)

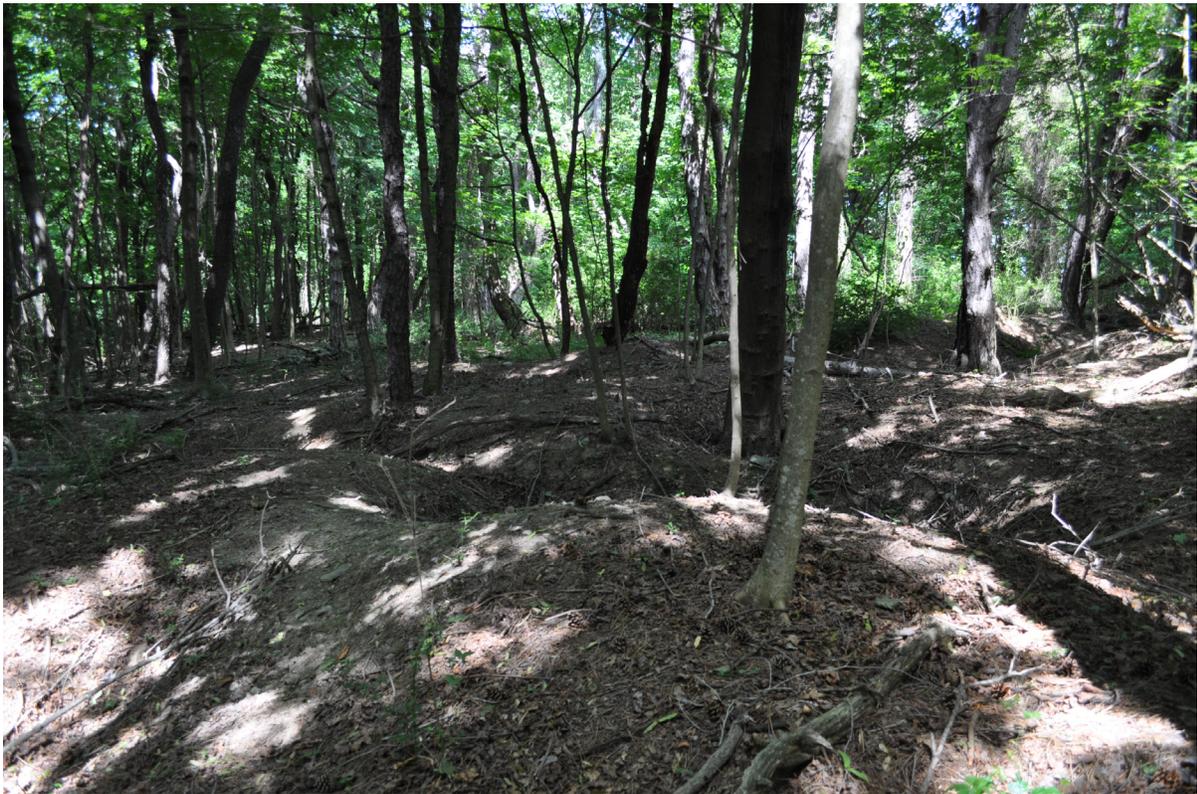
Figure 35. Remains of the hand-dug World War I-era training trenches are still visible on the north drumlin. (OCLP 2017, DSC-0509)

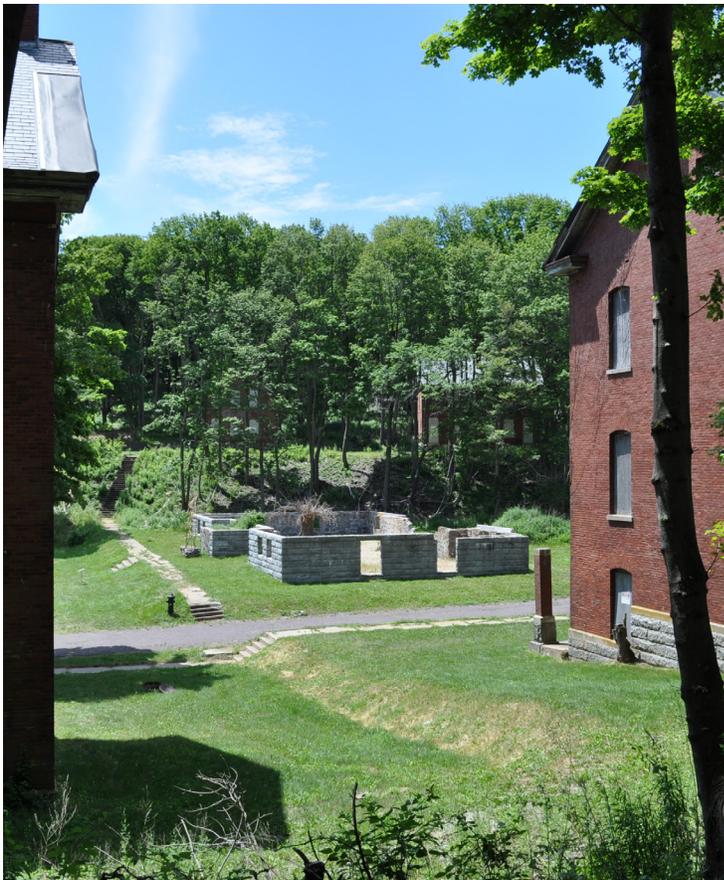
Figure 36. The army altered the topography to create level terraces for buildings, and built staircases to overcome substantial elevation changes between the parade ground and Officers' Row (in the background). View looking southwest. (OCLP 2017, DSC-0540)

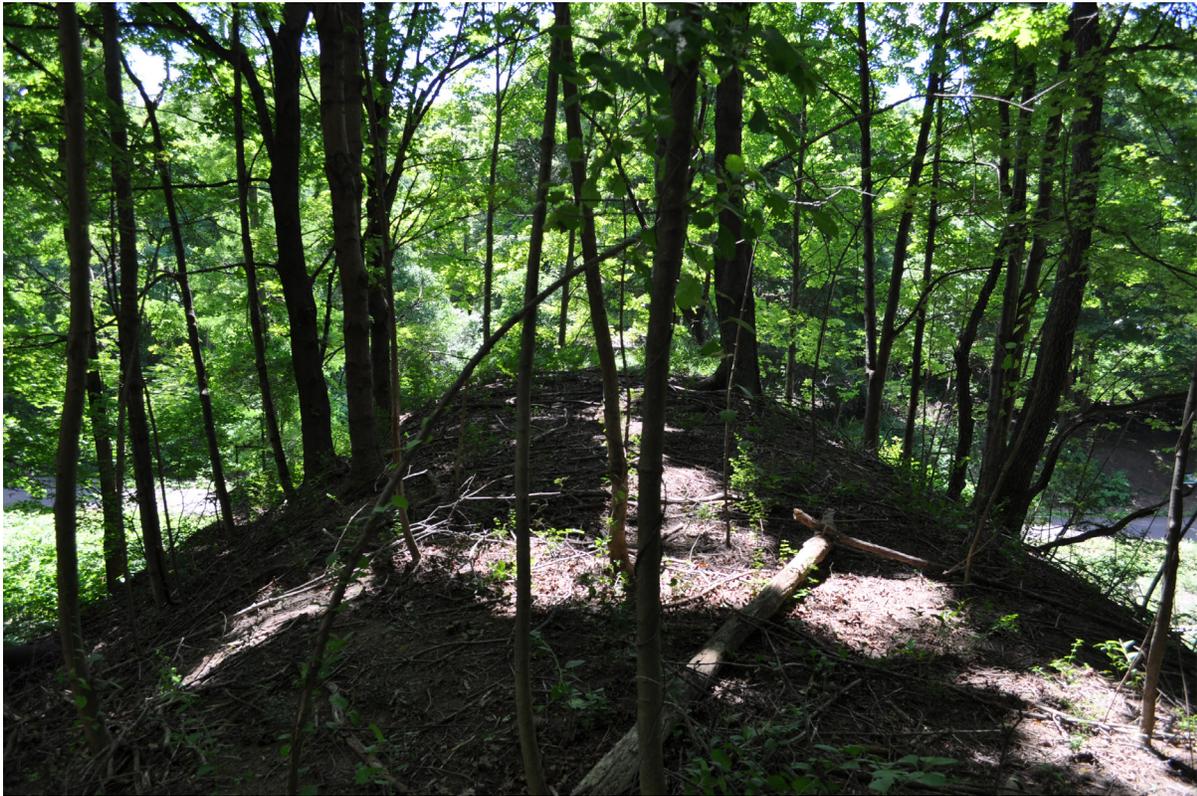
Figure 37. The contours of earthen embankment between the two mortar pits at Battery Cushing are still visible. View looking southwest. (OCLP 2017, DSC-0575)

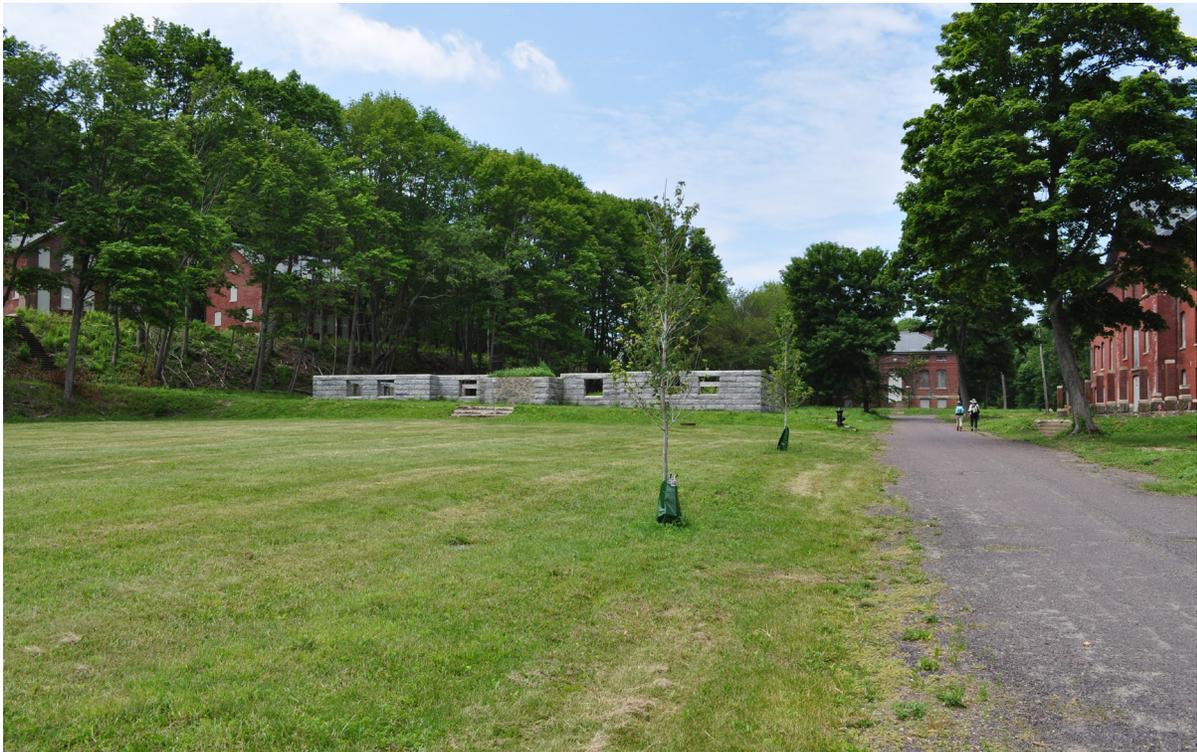
Figure 38. The park's retention of key buildings and road proximate to the administration building's foundation, and restoration of the parade ground, communicate the fort's historic design. Note the new maple trees along the main road. View looking west. (OCLP 2015, DSC-1154)

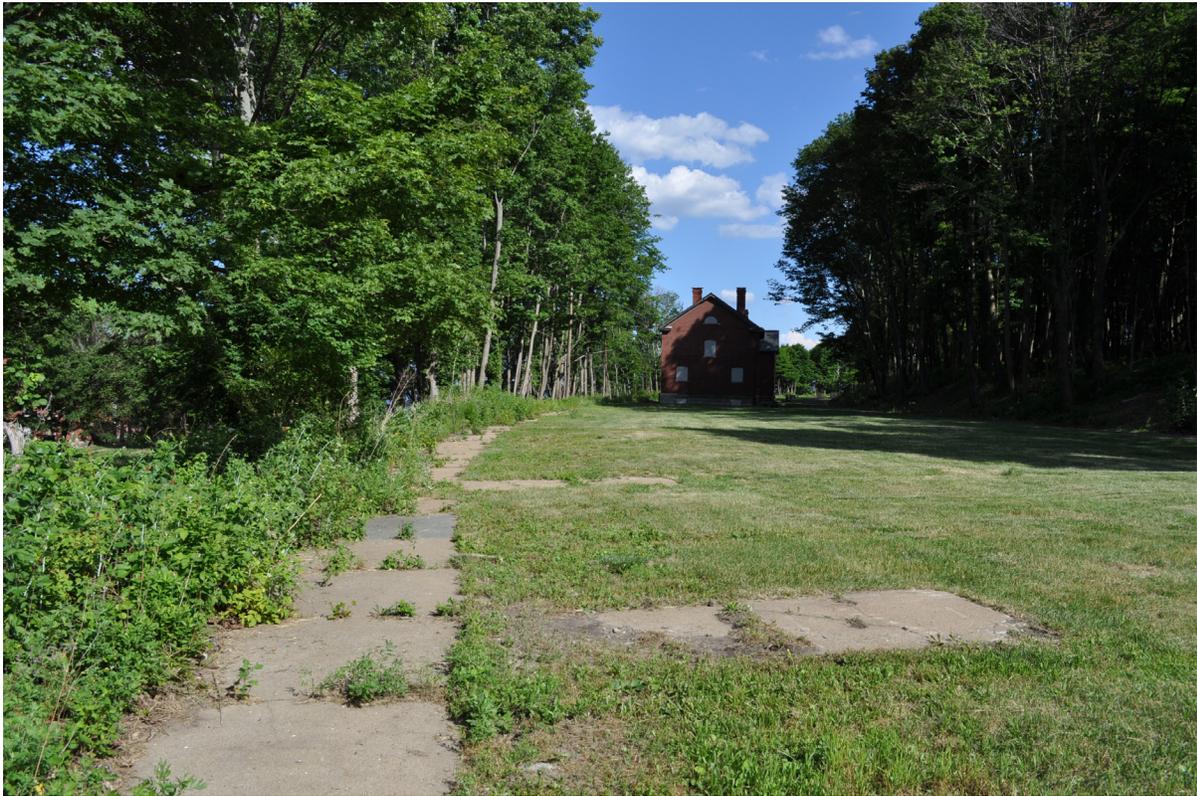
Figure 39. Open lawns, remnant walks and road, and remaining buildings reveal the curved layout of Officers' Row on the slopes of the south drumlin. View looking southeast. (OCLP 2017, DSC-0797)

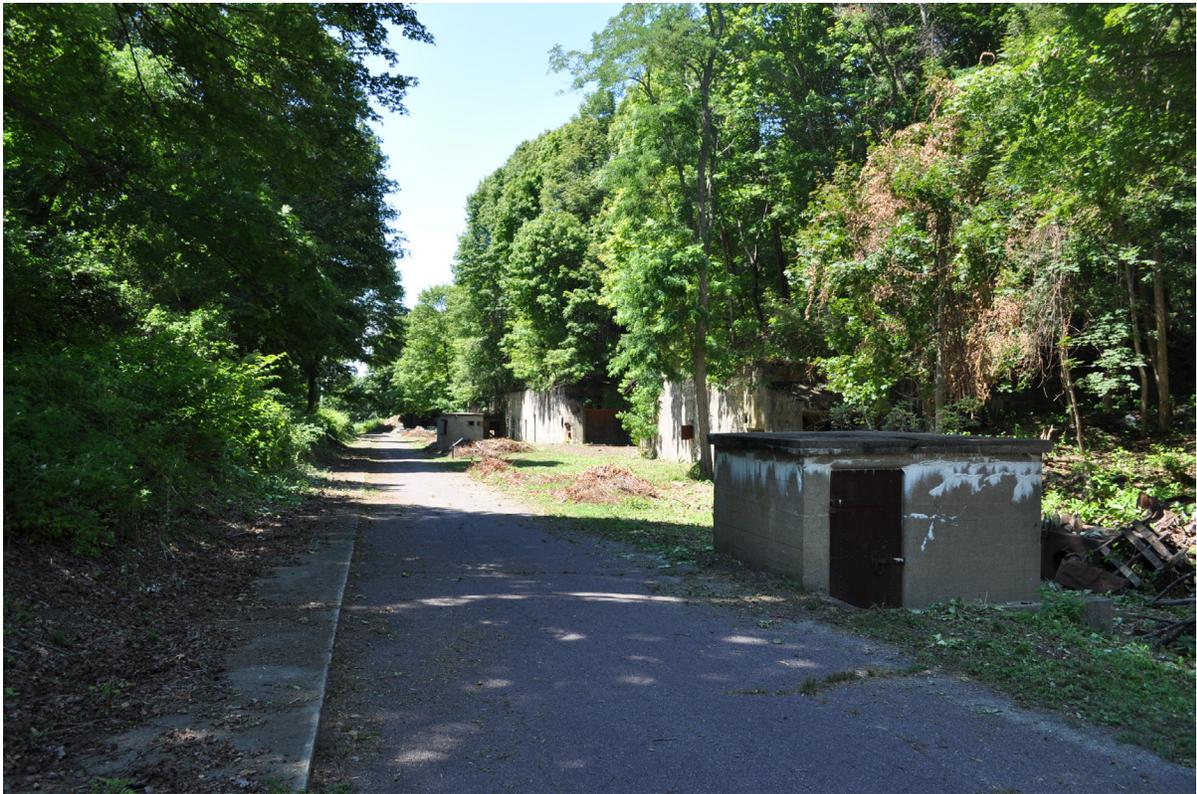
Figure 40. The orthogonal layout of the main road, sidewalk, and two mortar batteries contrasts with the curved layout of facilities along Officers' Row. View looking northwest. (OCLP 2015, DSC-0572)
