National Park Service
Cultural Landscapes Inventory
2018

Peddocks Island
Boston Harbor Islands National Recreation Area
Park Review Draft: 05/17/2018

Cultural Landscape Inventory Name	Peddocks Island
Cultural Landscape Inventory Number	650138
Parent Cultural Landscape Inventory Name	Peddocks Island
Parent Cultural Landscape Inventory Number	650138
Park Name	Boston Harbor Islands National Recreation Area
Park Alpha Code	BOHA
Park Org Code	1727
Property Level	Landscape

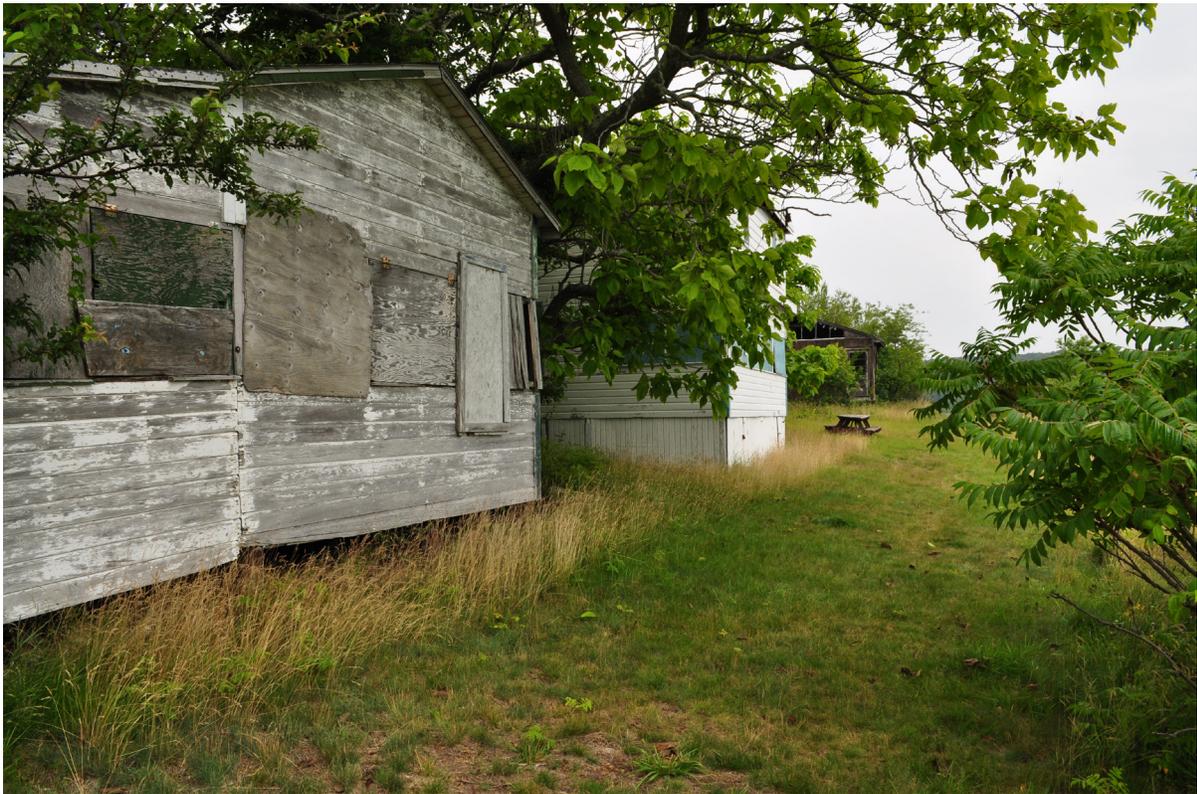
Figure 43. Row of cottages (#s, 6, 7, and 9) facing east, on the northeast side of Middle Head. Cottage #8 (at the picnic table) is missing. View looking north. (OCLP 2015, DSC-0987)

found objects that have washed onto the island's shores and provide local color (Figure 53). There are ten cottage sites where only traces of the demolished cottages remain (see Figure 43). (Stanton 2016: 46)

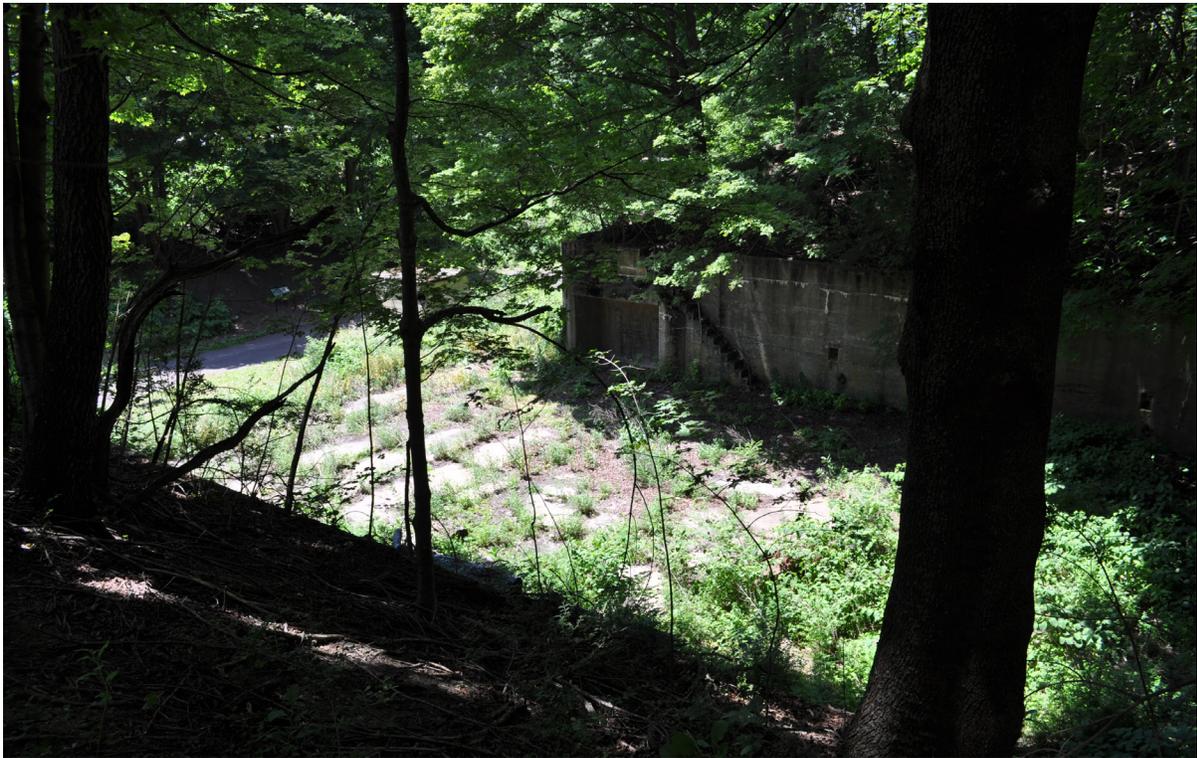
Figure 44. Visitors can now explore the eastern mortar pit of Battery Cushing, recently cleared of vegetation. View looking west. (OCLP 2017, DSC-0576)

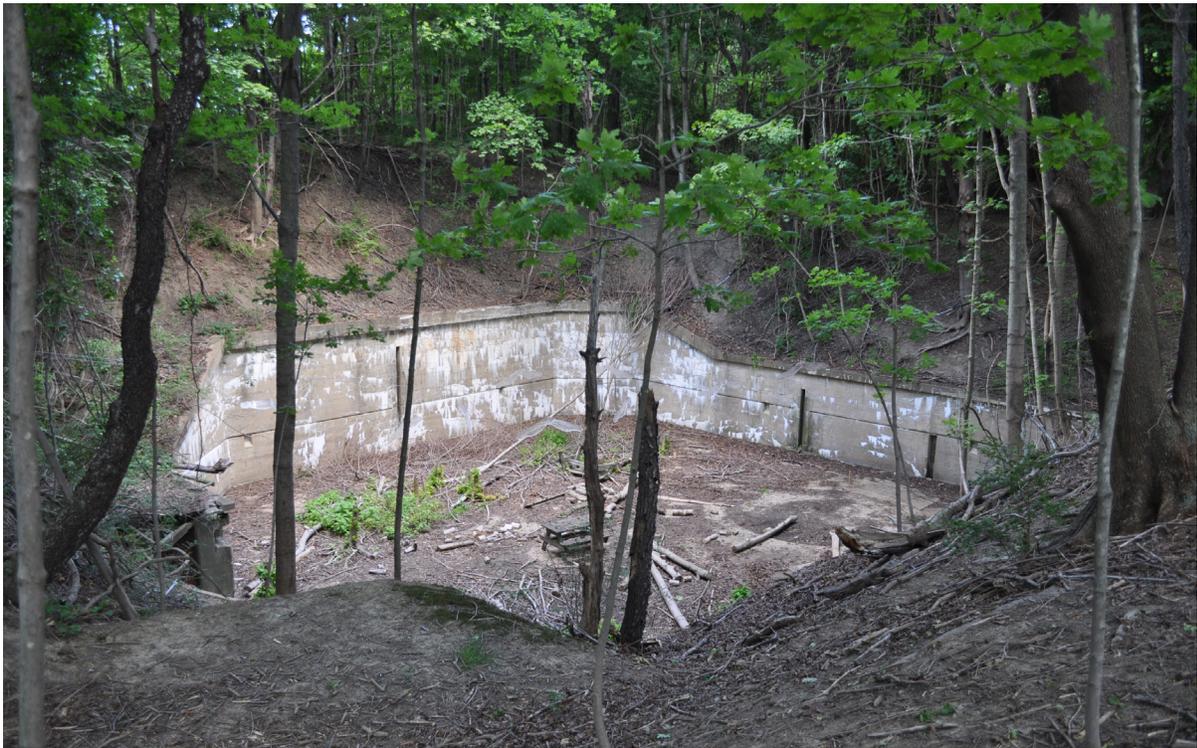
Figure 45. The park has cleared woody vegetation in the north mortar pit of Battery Whitman. View looking east. (OCLP 2017, DSC-0676)

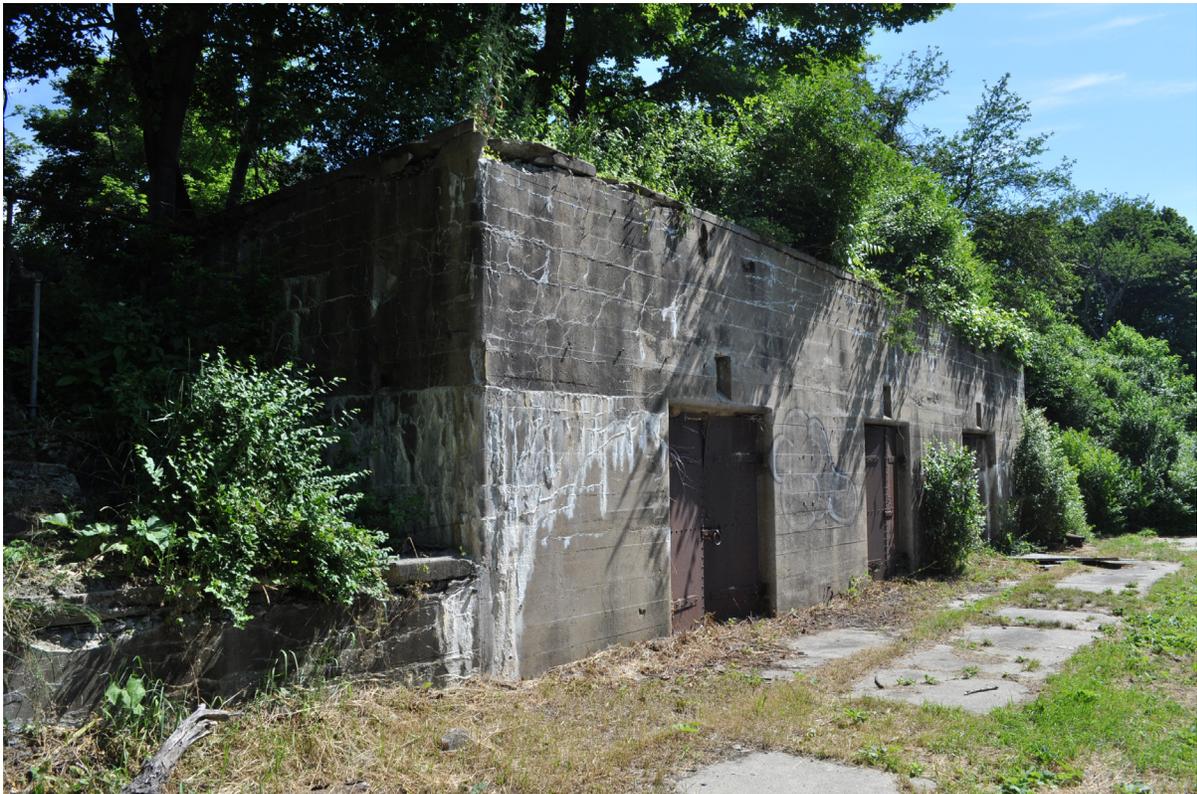
Figure 46. Overgrown vegetation on the rear elevations of Battery Bumpus and the two other gun batteries are mostly clear, but other components are cloaked in trees, shrubs, and vines. View looking northeast. (OCLP 2017, DSC-0458)

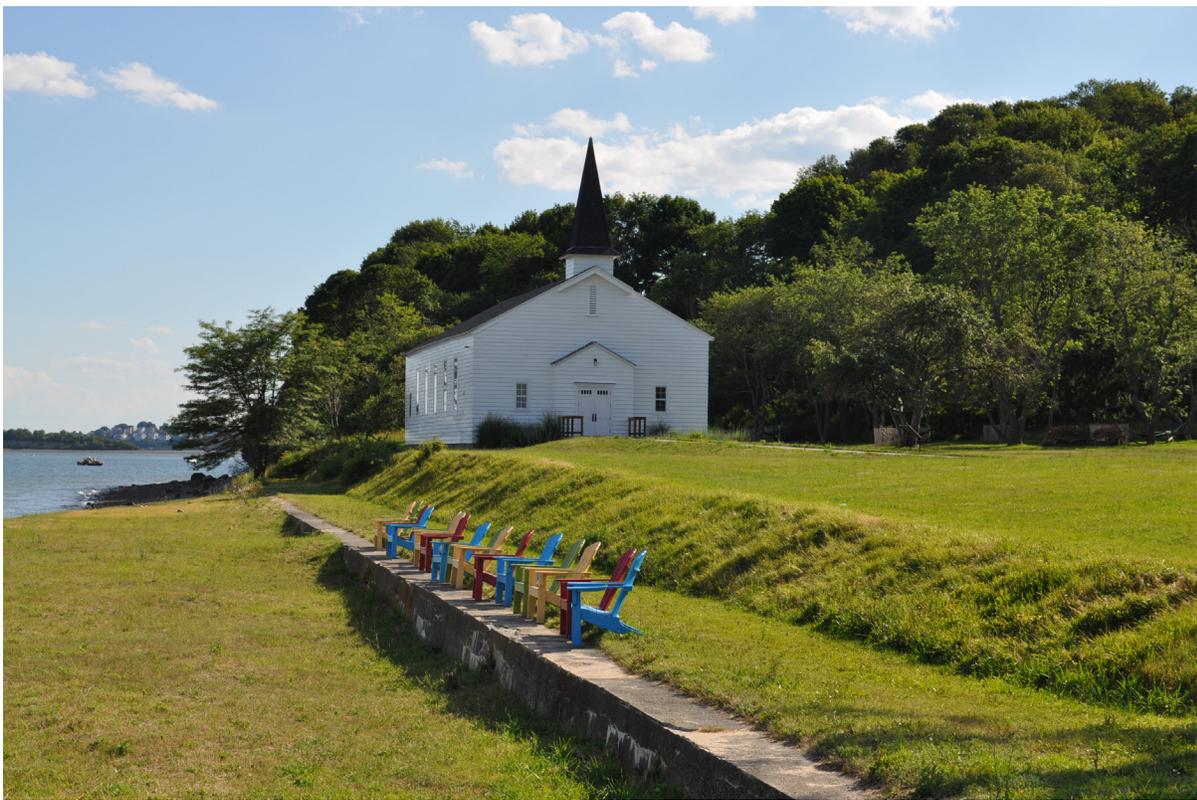
Figure 47. The chapel (#T-31) is fronted with new plantings, and a representative apple orchard stands just to the west. The 1912 army seawall (#48) is in the foreground. View looking southwest. (OCLP 2017, DSC-0849)

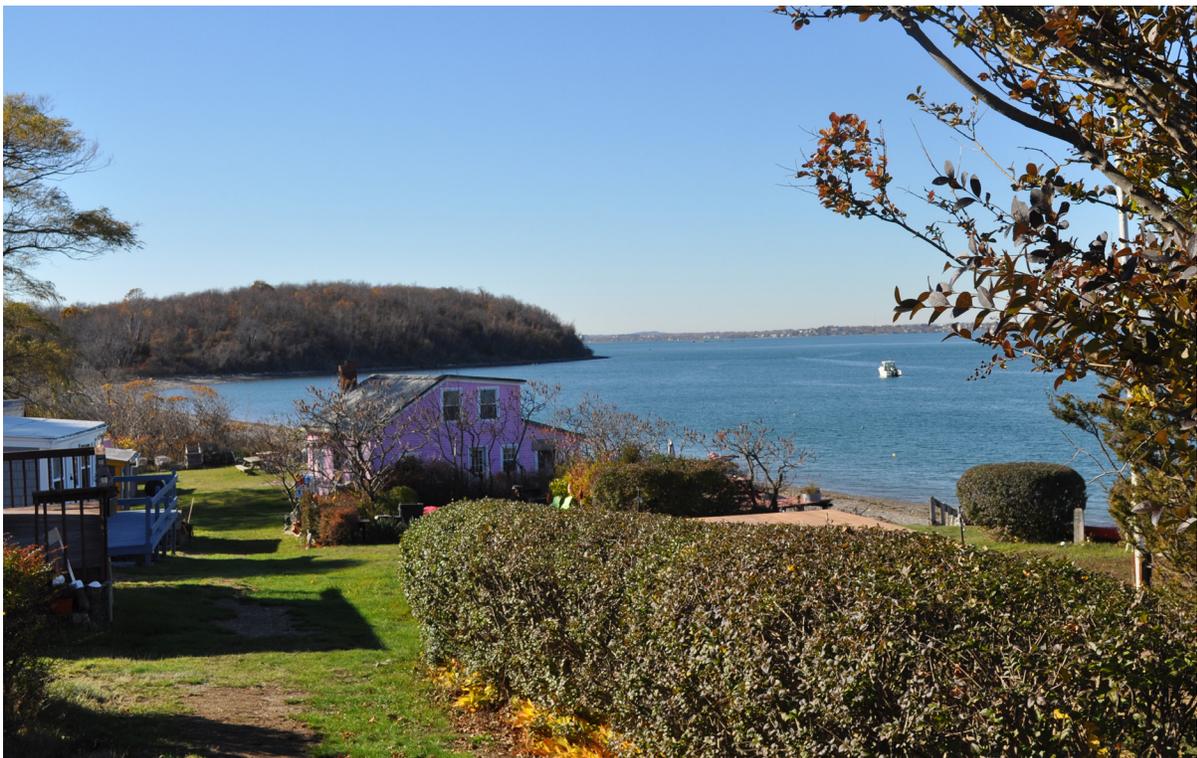
Figure 48. Some of the cottages on the northwest side of Middle Head are landscaped with a variety of small trees, shrubs, hedges, gardens, and lawns. View looking west. (OCLP 2016, DSC-5420)

vegetation remains dense in interior areas and along Crab Alley, but other cottages are more open and feature a mix of lawns, hedges, flower and vegetable gardens, and ornamental plantings (Figure 48).

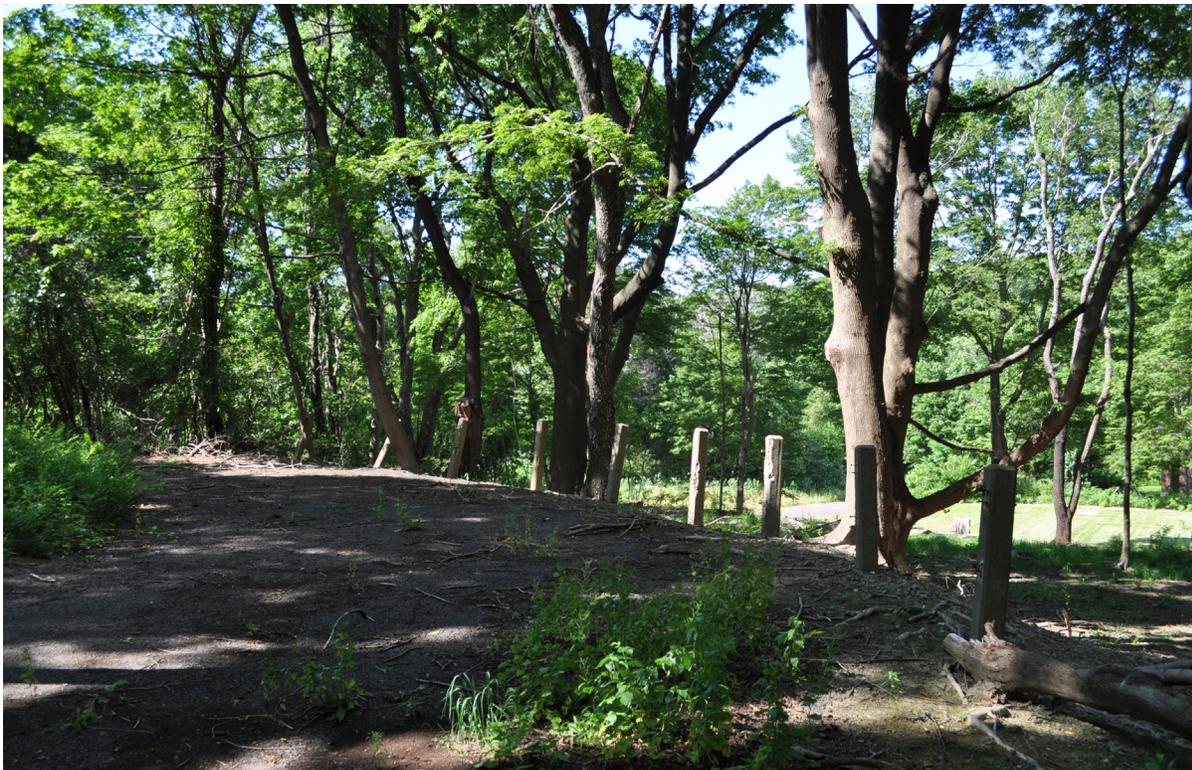
Figure 50. A trace of the roundabout where the roads in the World War II temporary facilities terminated are still visible on the south drumlin. Note the remnant concrete fence posts. View looking northwest. (OCLP 2017, DSC-0752)

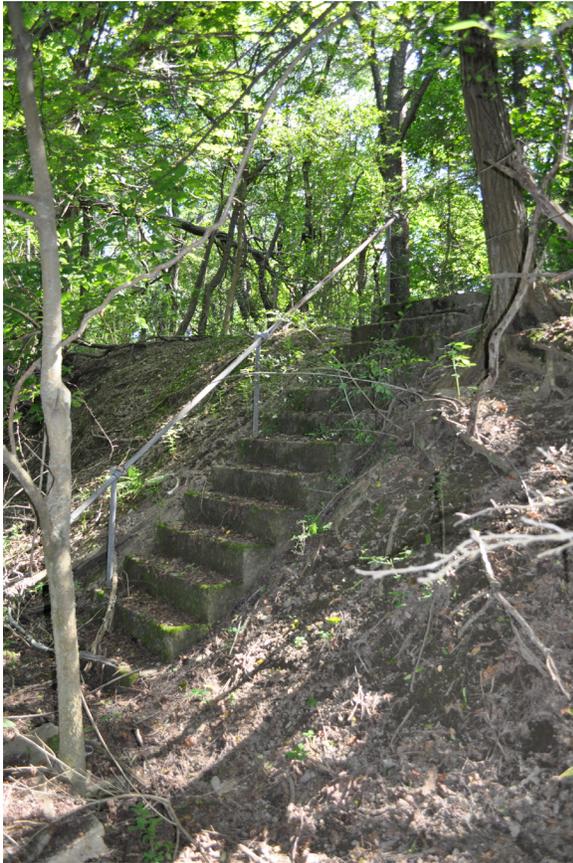
Figure 51. The only intact circulation feature at the top of the south drumlin is this staircase that accessed the ruins of the below-grade battery command/fire control structure (#F-105). View looking southeast. (OCLP 2017, DSC-0772)

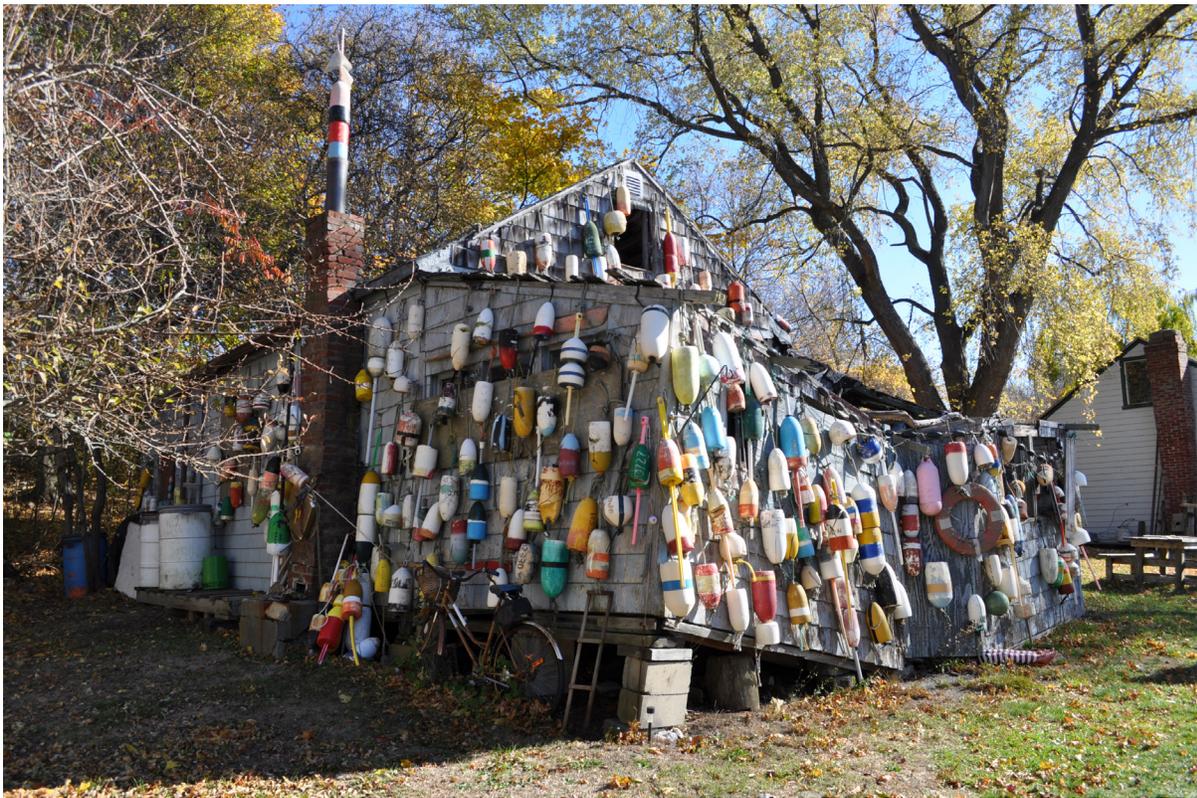
Figure 53. The decorated ruins of Cottage #32 on Crab Alley, Middle Head. View looking southeast. (OCLP 2016, DSC-0399)

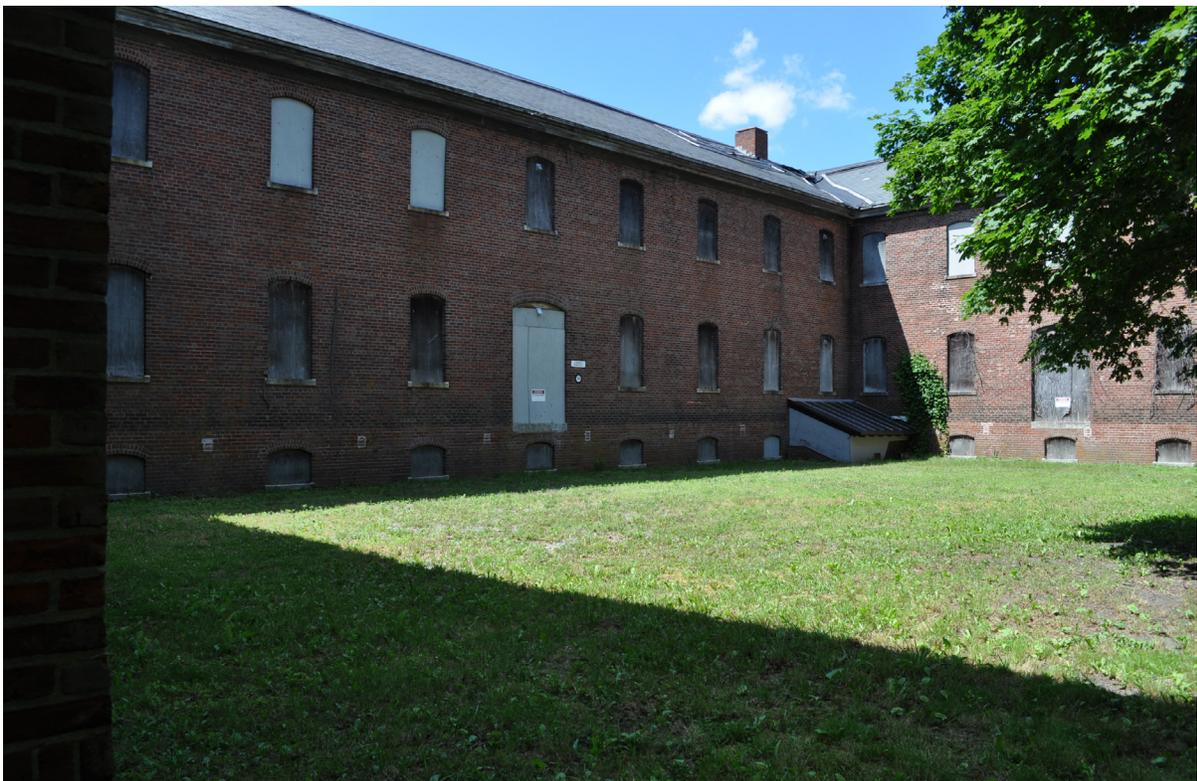
Figure 54. The U-shaped quartermaster storehouse (#36), the largest building at the fort, has been stabilized for future use. View looking north. (OCLP 2017, DSC-0705)

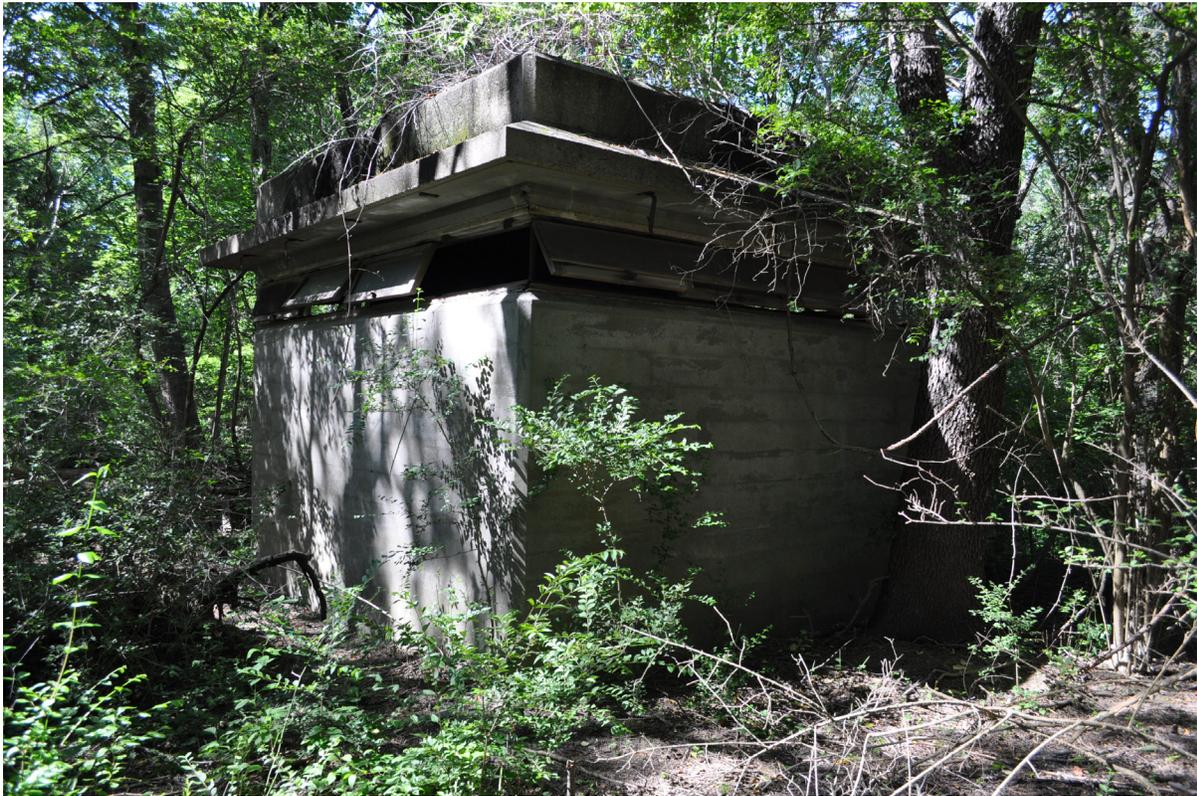
Figure 55. The ruins of the army’s observation station (#F-104), built in the early 1940s, on top of the south drumlin. View looking northwest. (OCLP 2017, DSC-0761)

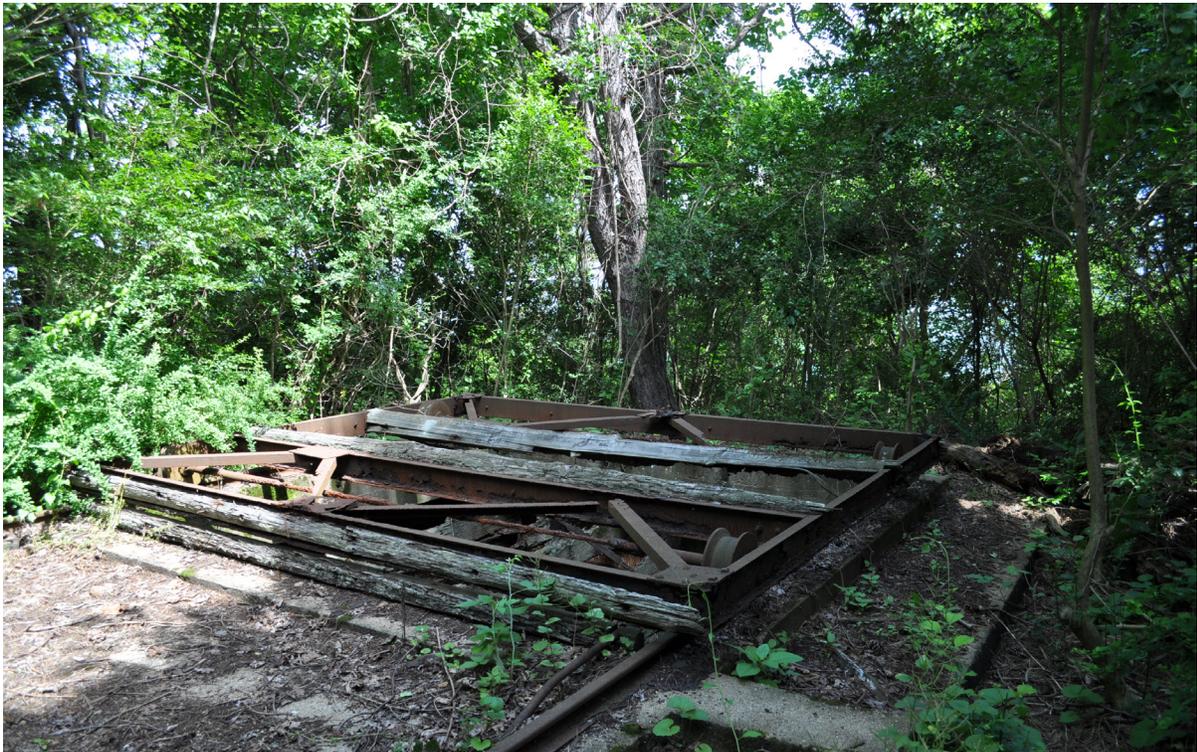
Figure 56. The remains of the 1924 “vertical lift” searchlight structure can be found on the north drumlin. A glimpse of the harbor is visible through the successional forest. View looking northwest. (OCLP 2017, DSC-0512)

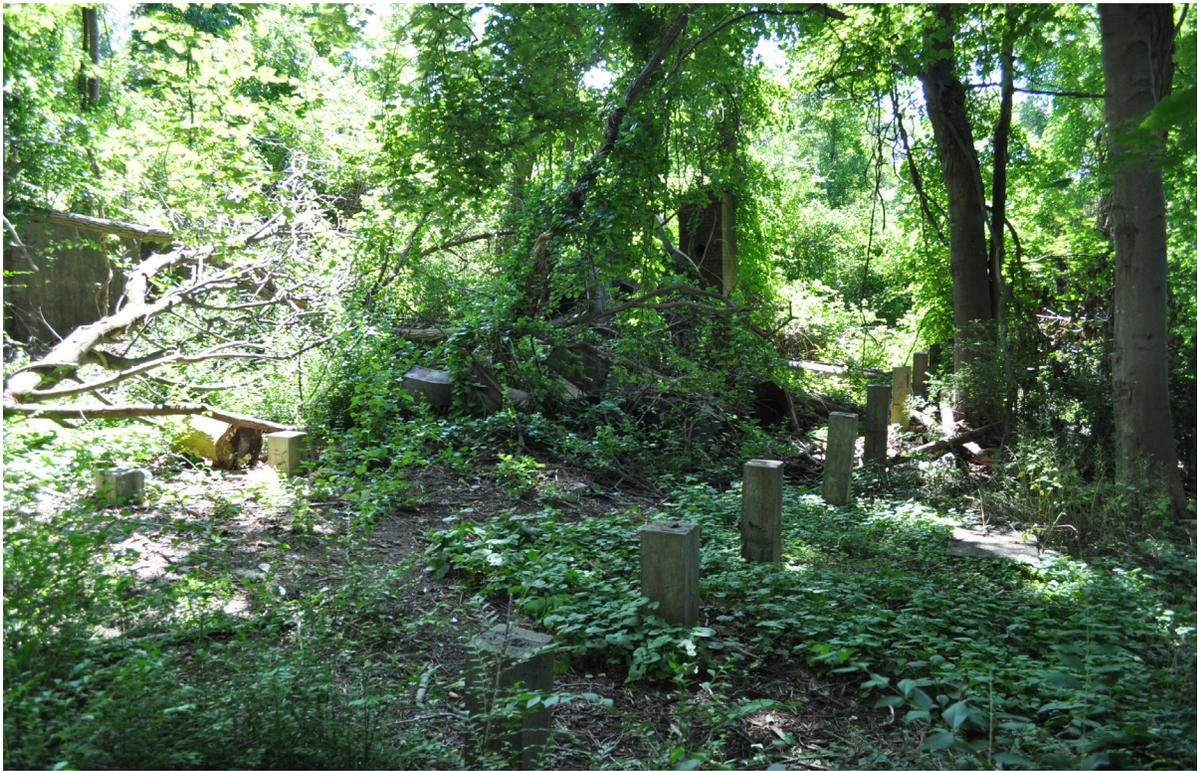
Figure 57. Concrete foundation posts, a brick chimney, and debris remain from a World War II-era temporary day room (#T-24) on the south drumlin. One of the concrete retaining walls built in this area is visible at image left. View looking west. (OCLP 2017, DSC-0724)

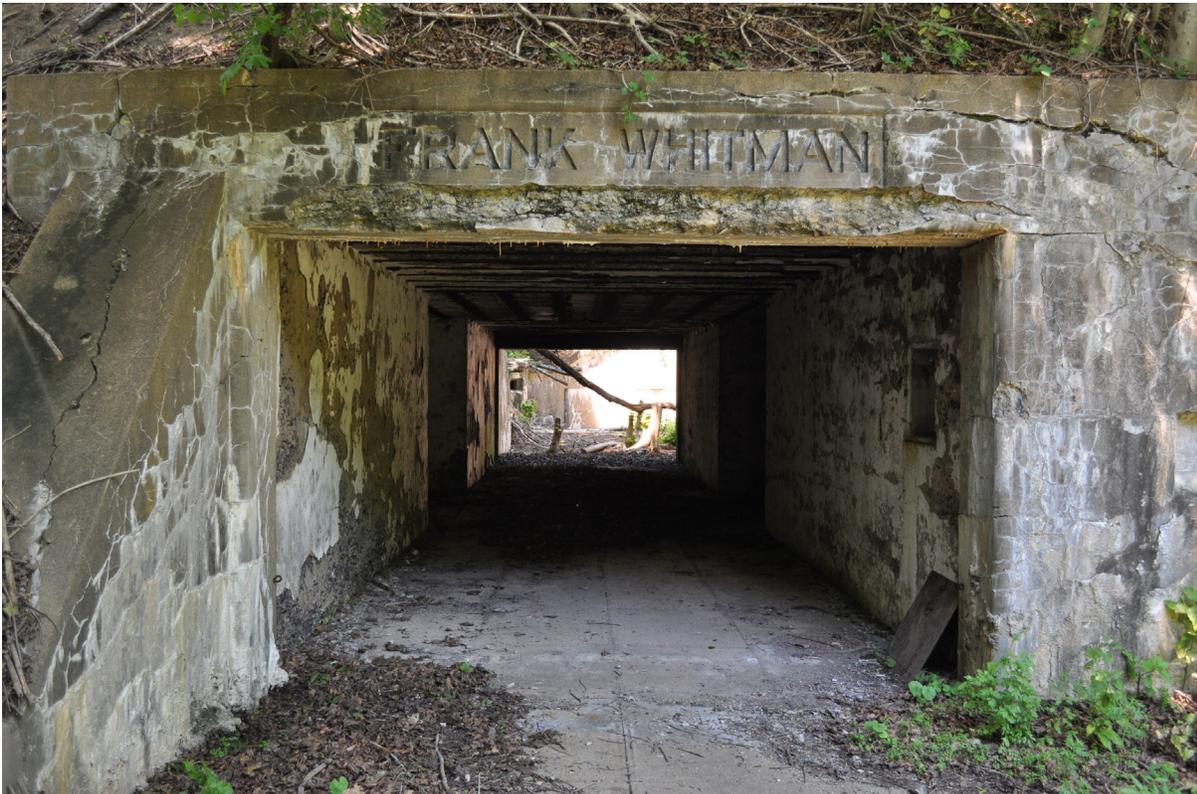
Figure 58. Visitors can explore the two pits and inner chambers of the 1898-1902 Battery Whitman. View looking northeast. (OCLP 2017, DSC-0663)

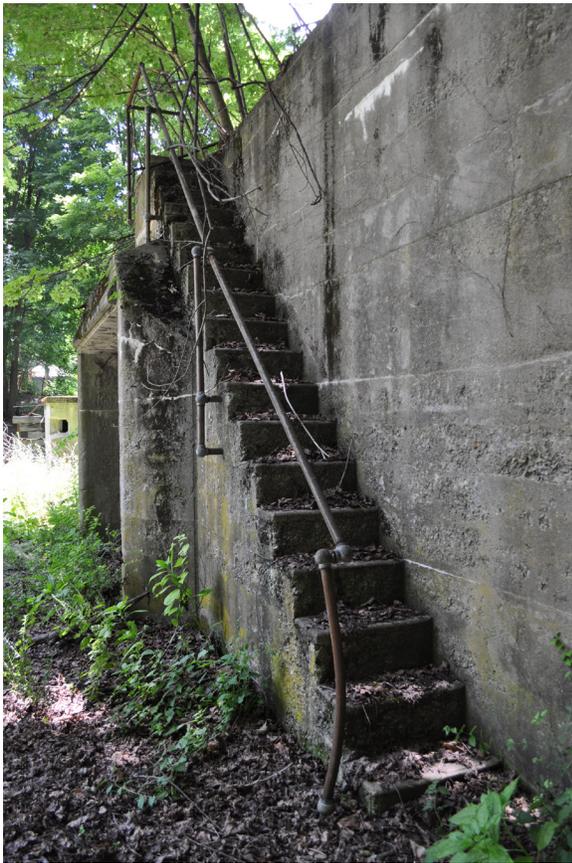
Figure 59. Stairs and railings in varying conditions remain throughout Battery Cushing, built in 1901-04. View looking southwest. (OCLP 2017, DSC-0614)

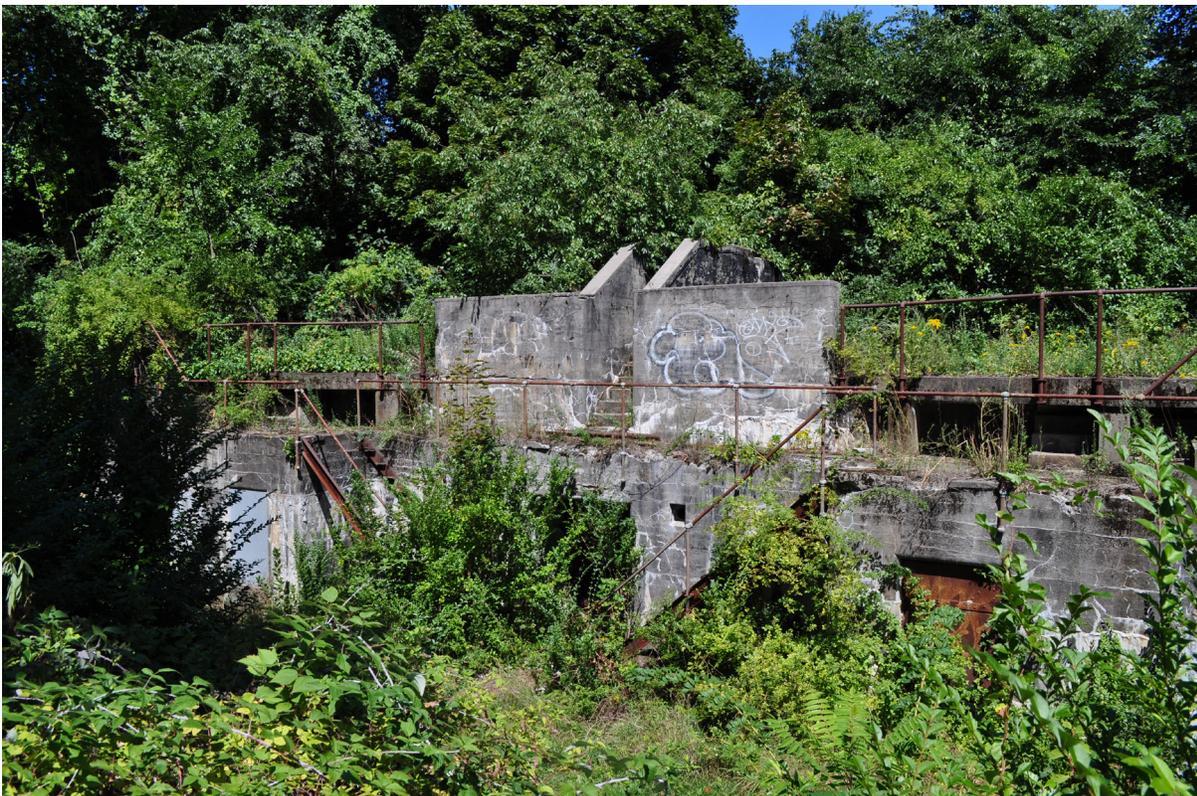
Figure 60. Vegetation envelops much of Battery McCook, built in 1901-04. View looking northwest. (OCLP 2014, DSC-0096)

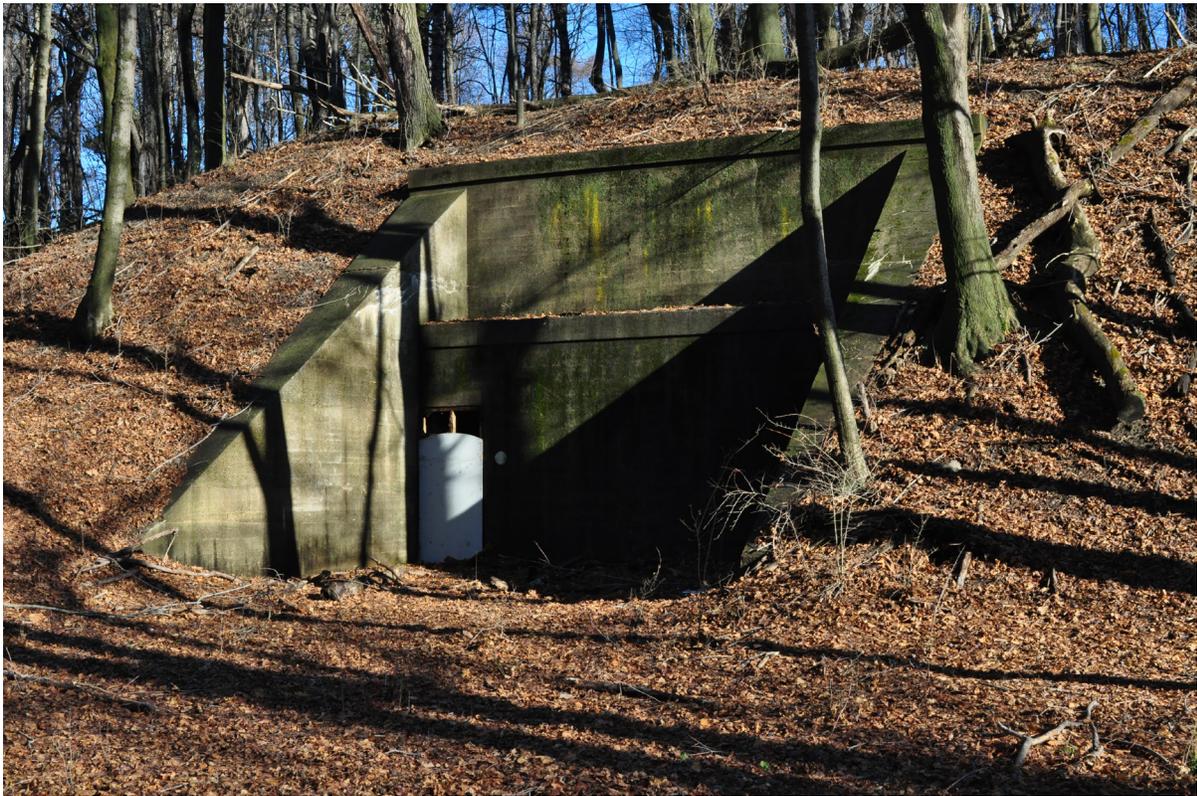
Figure 61. The concrete ordnance storehouse was built into the north drumlin in 1906. View looking north. (OCLP 2015, DSC-6339)

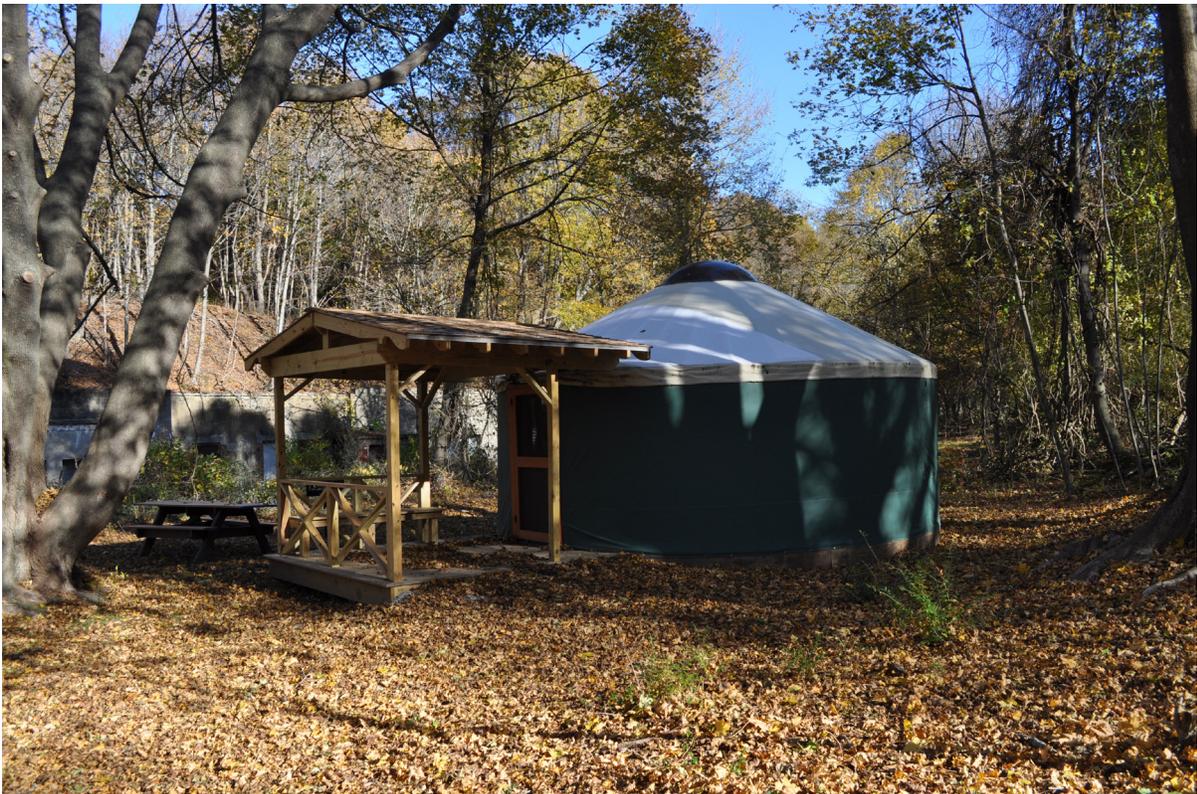
Figure 62. Yurts in the campground across from the mortar batteries feature covered porches. View looking east. (OCLP 2014, no#)

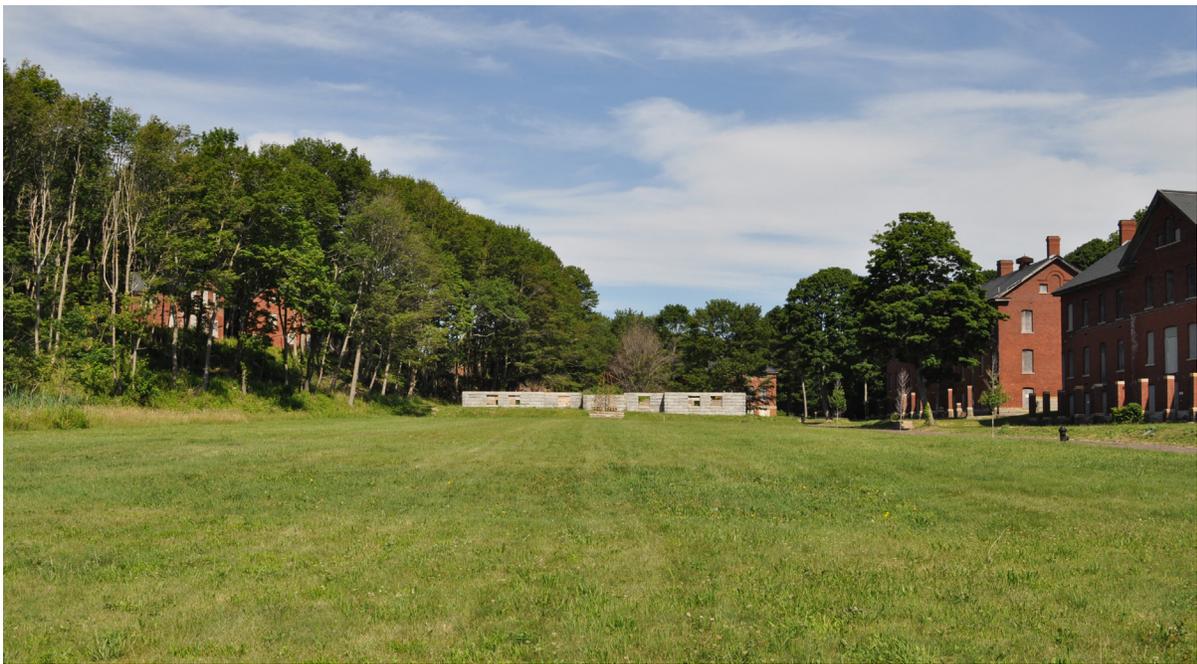
Figure 63. The historic view from the parade ground has been restored, and compares well with the scene in Figure 14. View looking west. (OCLP 2017, DSC-0429)

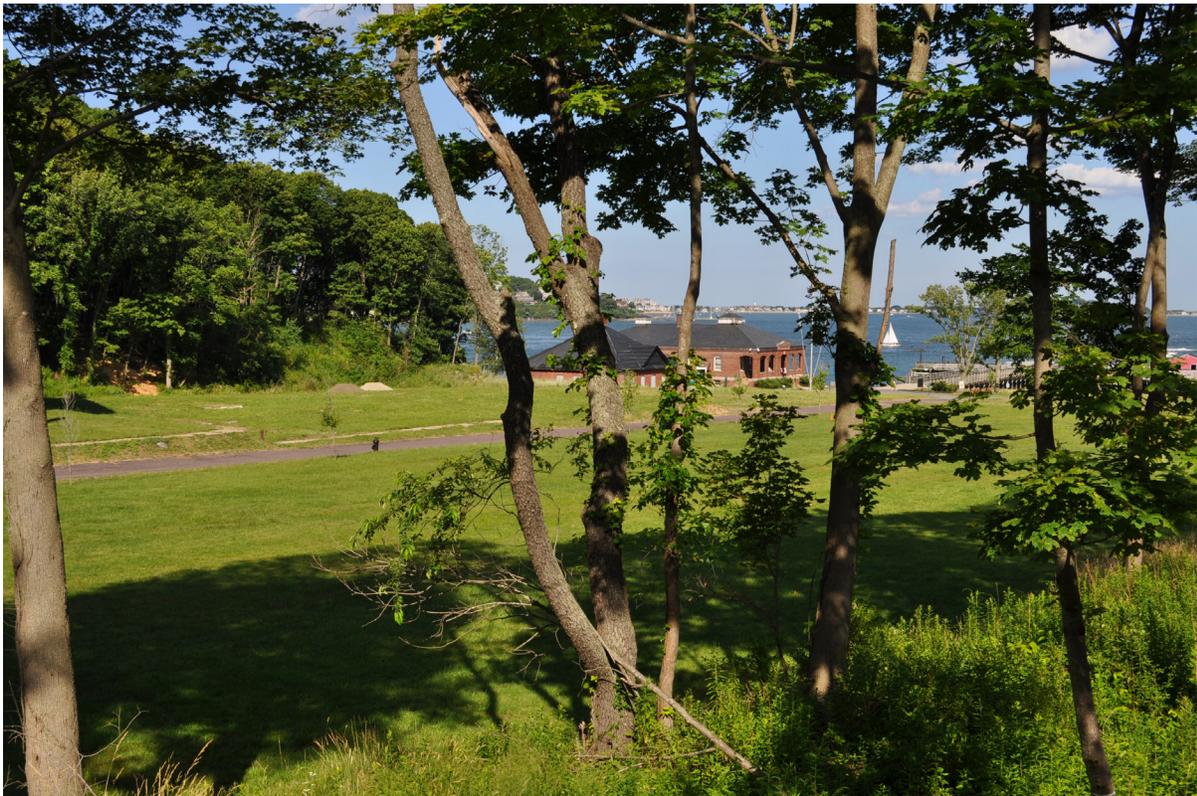
Figure 64. Selective tree removals have partially reopened the views from Officers' Row to the parade ground, wharf, and harbor. View looking northeast. (OCLP 2017, no#)

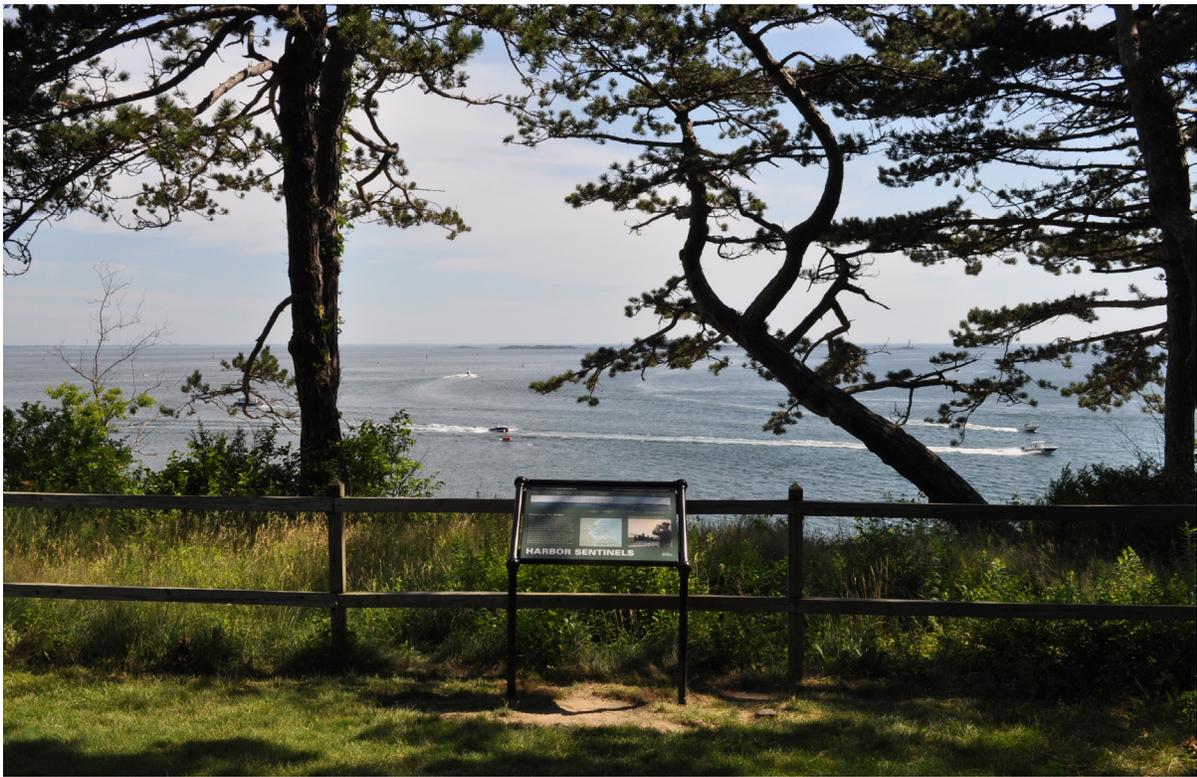
Figure 65. The overlook on the north drumlin allows visitors to experience the harbor view that was once visible from the nearby gun batteries. View looking north. (OCLP 2017, DSC-0440)

In 2012 the park removed a large area of trees on the north drumlin for a campground, restoring historically open conditions around the battery observation tower (#F-101). Although dense vegetation still blocks access to the three gun battery ruins and the important outward views from them, this condition is reversible. This same project also created an overlook northeast of the gun batteries, which provides framed views of the Nantasket Roads and the harbor (Figure 65). Vegetation removal has improved views of the two mortar batteries from the main road and the adjacent campground that was developed in 2016. However, views from the former observation and communication facilities atop the south drumlin to the mortar batteries and the harbor are still blocked by trees. As with the gun battery views, these too can be restored by tree removal and thinning.

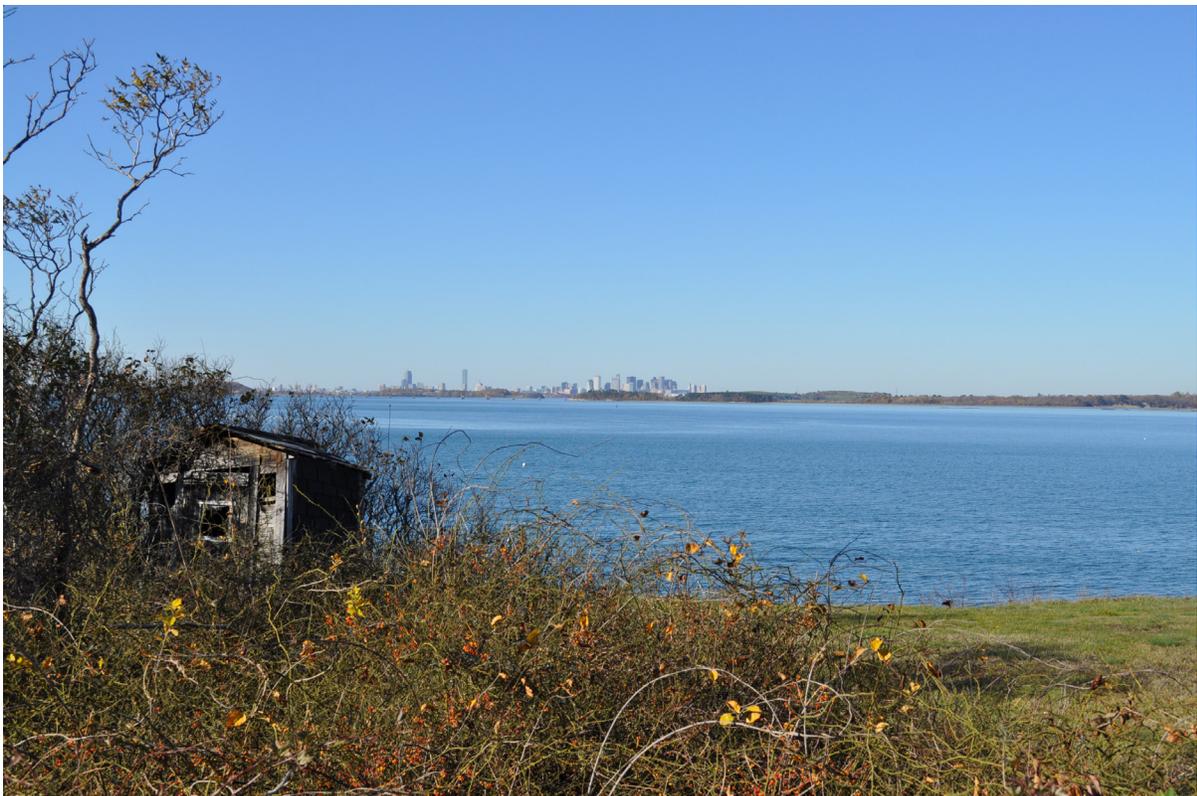
Figure 66. View of the harbor islands and downtown Boston from Middle Head. View looking northwest. (OCLP 2016, DSC-0466)

Panoramic water views on Middle Head and West Head are mainly from the cottages and roads/trails along the shorelines, as interior areas remain densely vegetated (Figure 66). Views from the northwestern shoreline include Rainsford Island, Long Island, Moon Island, and Downtown Boston, while views from the northeastern shorelines include Prince Head, Bumpkin Island, Sheep Island, Grape Island, and the Towns of Hull and Hingham. Similar views can be found on West Head, mostly from the shorelines. The panoramic views from the tombolos connecting the three heads are extant.

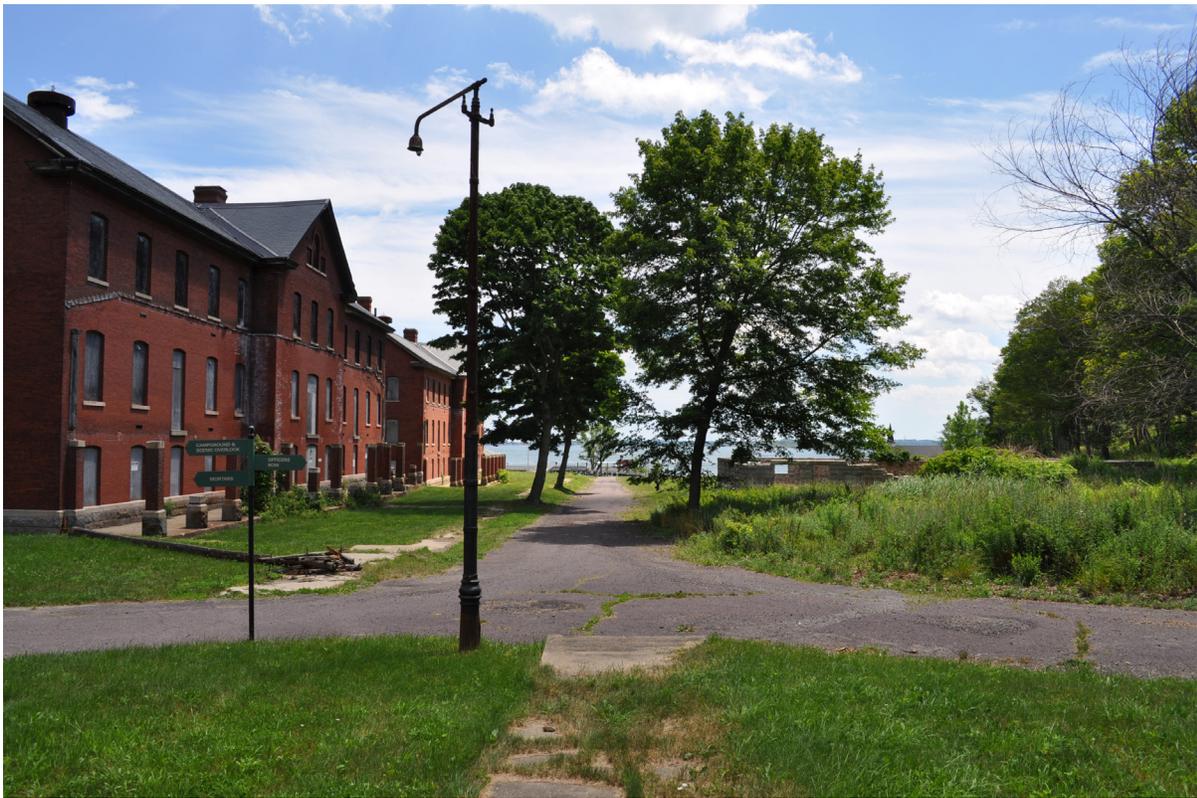
Figure 67. A historic light pole still stands in front of the recreation hall. View looking east. (OCLP 2017, DSC-0549)

Extant historic small scale features at Fort Andrews include fire hydrants, several lamp posts and bases of lamp posts, remnants of utility poles, the chain link fence at the south boundary, concrete post and wood board fencing remnants on the south drumlin, and a stone monument on the north drumlin (Figure 67). The historic flagpole location is no longer visible, but the park has erected a new flagpole next to the new guardhouse, which is aligned with the dock and lit with floodlights (Figure 68). The gas pump and large wood sign are gone, and the lettering on the Officers' Row hillside is no longer extant (it may be hidden under the understory vegetation). Contemporary small scale features at the fort include metal grills, wood
