# PEDDOCKS ISLAND

## Redevelopment Guide

**Scope:** The intention of this document is to catalog the existing historic structures on Peddocks Island and guide their compatible adaptive reuse. The introductory section provides contextual information on the island as a cultural and recreation resource. The later sections catalog existing buildings, focusing on their structural condition, historic integrity, and remaining hazardous materials.

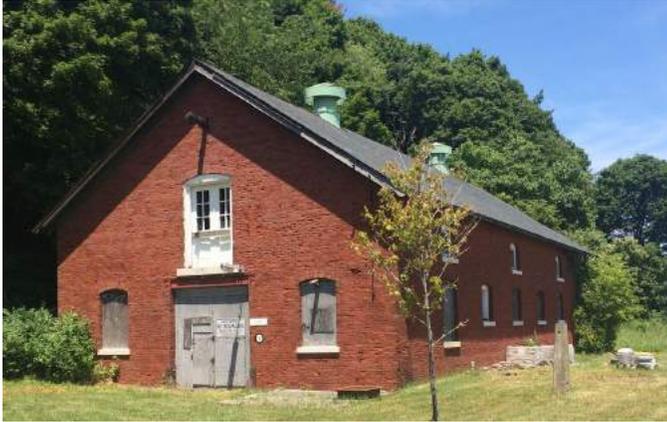
S. stable entry present.

**State of interior:** Interior structure sound and clear of debris. Existing stairs are sound. Wooden plank flooring at ground level are deteriorated.

**Brick and stonework:** Some spalling to brick surfaces. Exterior needs repointing.

**Abatement:** Asbestos in window and door caulking. Some interior paint may still contain lead.

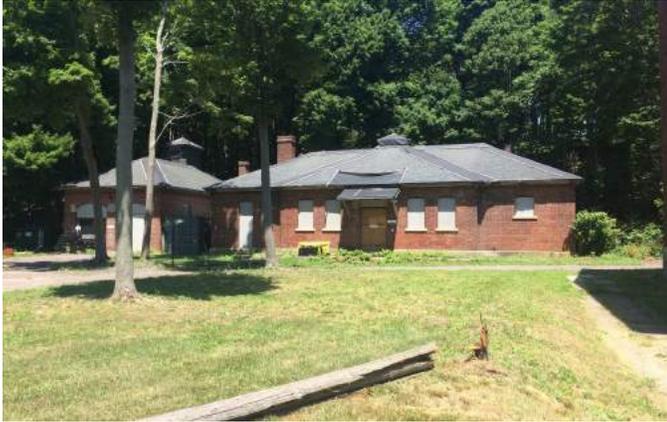
Building 08 from S. with Bldg. 33 to left.

**Structural stability:** In stable condition. Most rafters in poor or failed condition have been sistered and stabilized.

**Brick and stonework:** Needs minor repointing. Exterior front slab needs major repair or replacement.

**Roof and gutters:** Requires new roofing along all ridges and valleys, over entry and to central lantern. Gutters need some repair. Three rafters have been sistered above entry and structurally shored up.

**Abatement:** Loose debris were cleared from building. Friable asbestos containing materials still present in Boiler Room and small closet spaces. Damaged insulation in boiler room repaired with wet wrap.

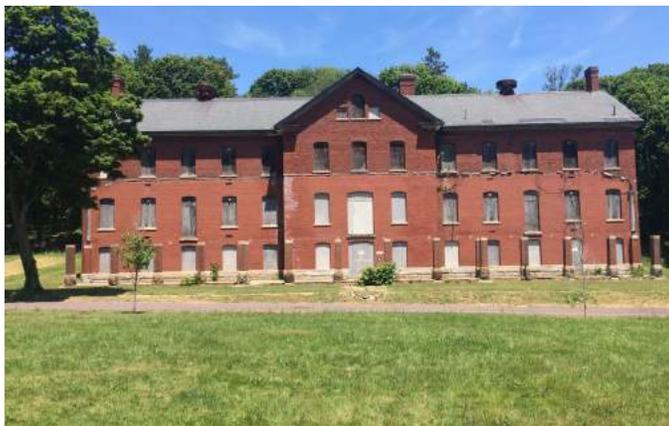
Building 10 from Parade Ground, note silhouette from removed verandah.

**State of interior:** Staircase has collapsed (less extensive than in Bldg. 11). Water damage down to basement. Full or partial rebuilding of floors necessary.

**Roof and gutters:** Requires new roofing along all ridges and valleys to replace temporary rubber roofing. Some rafters in need of replacement due to water damage.

**Abatement:** Loose debris cleared and damaged pipe insulation/ fittings removed from boiler room. Friable Asbestos-containing materials remain in the boiler room and pipe insulation. Window & door caulk contains asbestos.

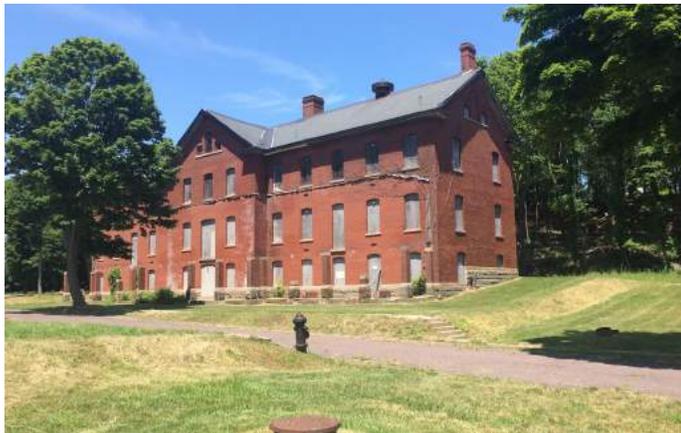
Building 11 from Parade Ground.

**State of interior:** Staircase has collapsed. Extensive water damage on all levels along S. gable and collapses under roof valleys.

**Brick and stonework:** Minor repointing. Repair to crack above one window. Three porch columns need rebuilding and porch slab needs significant restoration.

**Roof and gutters:** Valley framing may need replacement. Corners of cornices need repair. Requires new roofing along all ridges and valleys to replace temporary rubber roofing.

**Abatement:** Floor cleared of debris. Friable Asbestos-containing materials remain in the boiler room and pipe insulation. Damaged boiler jacket and damaged piping insulation was removed. Window & door caulk contains asbestos.

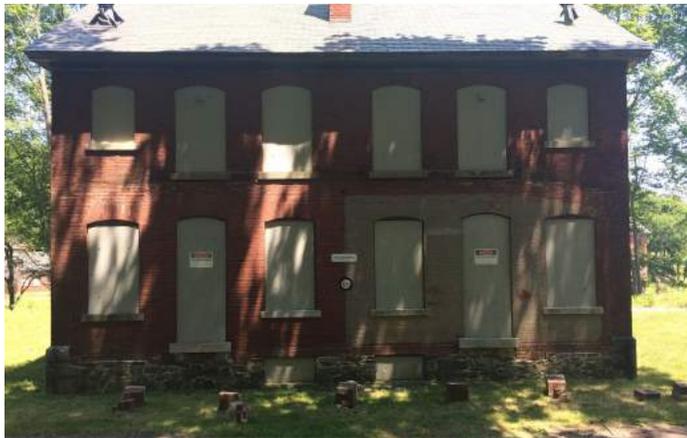
Building 15 S. elevation today.

**Structural stability:** Stable, in good condition. Porches have been removed.

**State of interior:** Good condition except for portion of first floor which has been covered in plywood for access. Temporary railing installed at stair opening. Loose plaster removed.

**Brick and stonework:** Minor repointing and repairs to porch columns.

**Roof and gutters:** Roof protection in place of valleys, ridges & flashing. In good condition overall.

**Abatement:** Building is cleared of debris. Asbestos remains in the rough coat wall and ceiling plaster. Window & door caulking was removed.

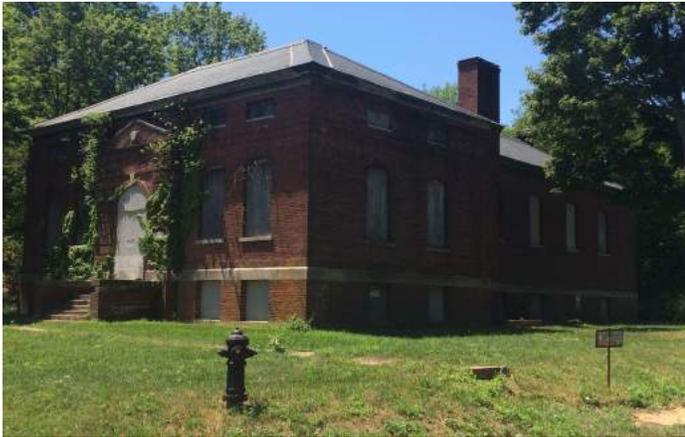
Gymnasium from NE corner.

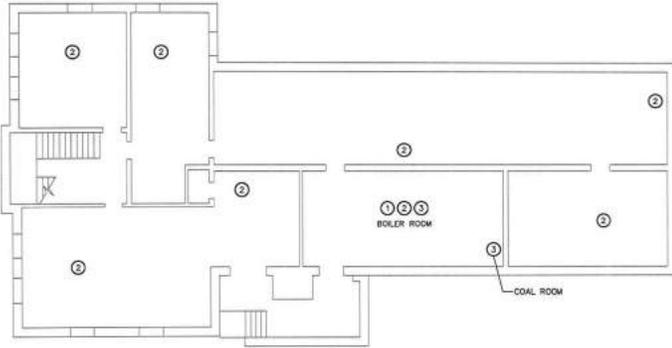
Basement level with bowling alley.

①	FRIABLE THERMAL SYSTEM INSULATION (TSI) JACKET ASSOCIATED WITH BOILER	65 SF
②	FRIABLE PIPE INSULATION & ASSOCIATED MUDDED FITTINGS	328 LF
③	FIBER CEMENT BOARD (TRANSITE) CEILING PANELS	605 SF

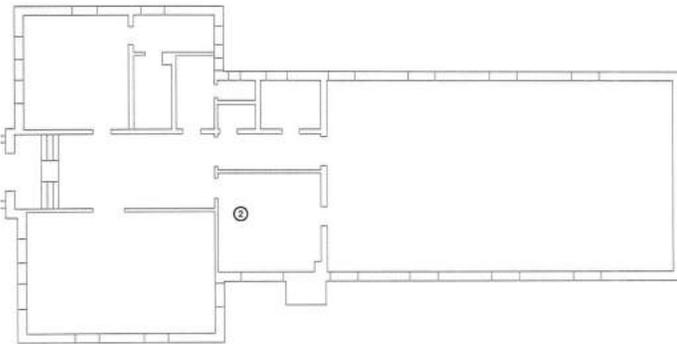
First floor with court (raised above grade).

①	FRIABLE THERMAL SYSTEM INSULATION (TSI) JACKET ASSOCIATED WITH BOILER	65 SF
②	FRIABLE PIPE INSULATION & ASSOCIATED MUDDED FITTINGS	328 LF
③	FIBER CEMENT BOARD (TRANSITE) CEILING PANELS	605 SF

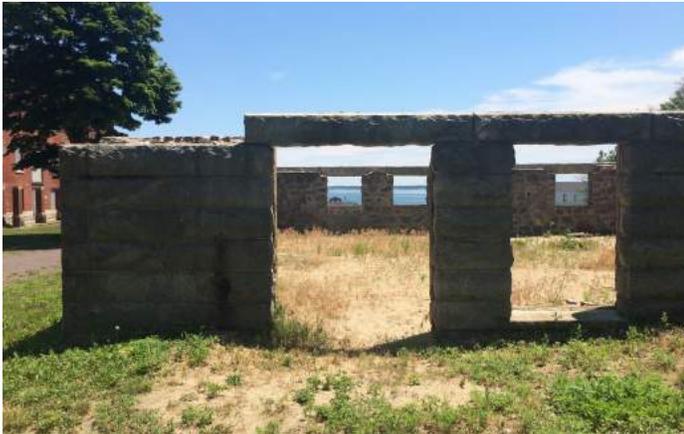
Looking E. towards Building 26 foundation.

**Structural stability:** Foundation walls are stable.

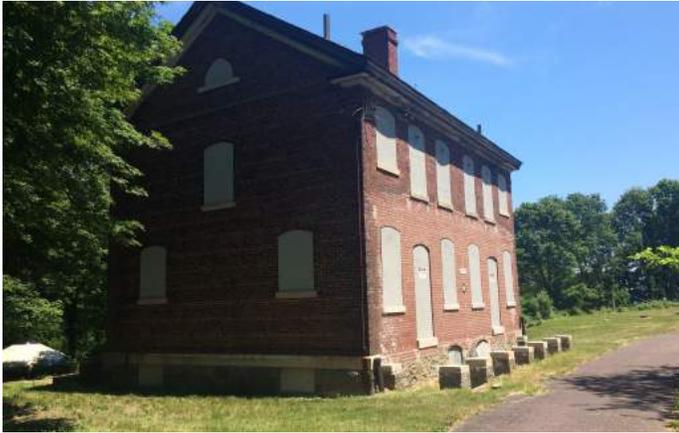
View of Building 27 heading E. along Officers Row.

**Structural stability:** Building is stabilized and in good condition. Porches removed.

**Roof and gutters:** Roof protection in place over ridges, valleys, and flashing. In generally good condition. Roof ridge needs replacing.

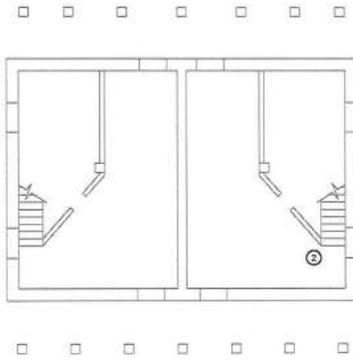
Basement.

①	VENT PAPER	20 SF AND ALLOWANCE FOR CONCEALED MATERIAL
②	FIBER CEMENT BOARD (TRANSITE) CEILING PANELS	100 SF
③	FLUE CEMENT	2 SF

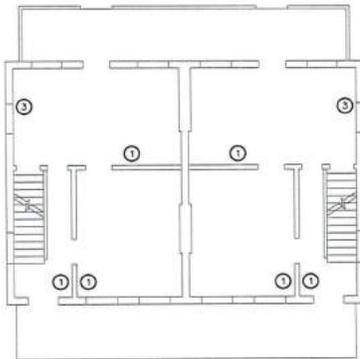
First floor (raised above grade).

①	VENT PAPER	20 SF AND ALLOWANCE FOR CONCEALED MATERIAL
②	FIBER CEMENT BOARD (TRANSITE) CEILING PANELS	100 SF
③	FLUE CEMENT	2 SF

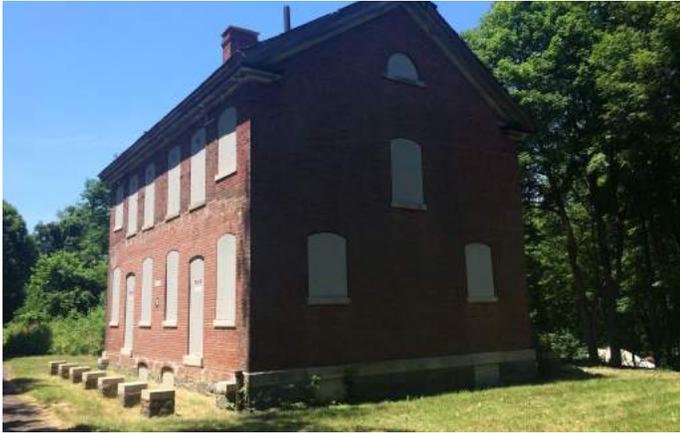
Building 28 looking W.

**Structural stability:** Good stable condition. Porches have been removed.

**Roof and gutters:** Damage to cornicing at west peak needs attention.

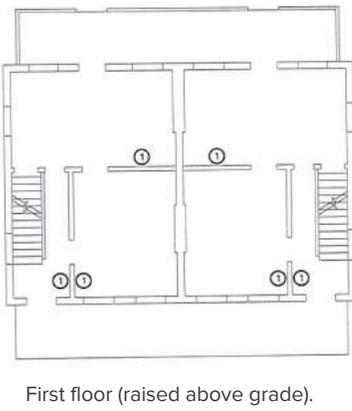
① VENT PAPER 30 SF

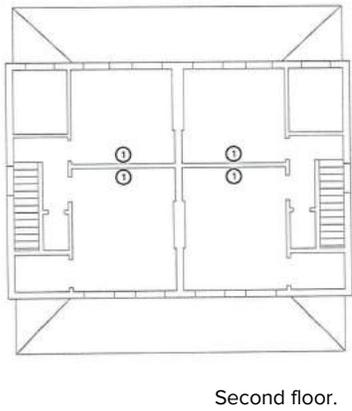
① VENT PAPER 30 SF

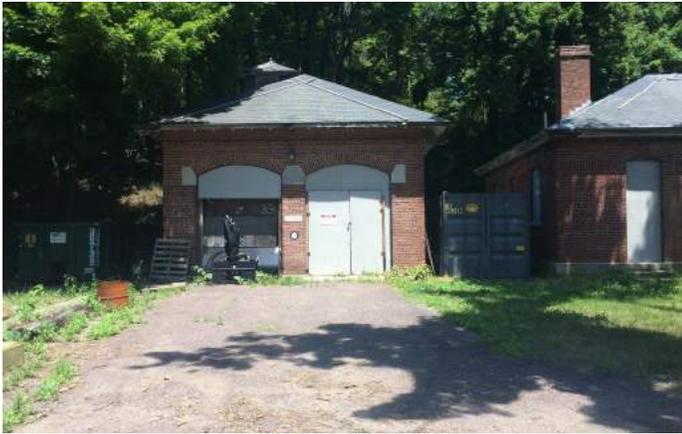
S. elevation of Building 33 with pair of doors.

**Roof and gutters:** Roof protection in place. No signs of structural issues. Isolated damage to cornice. Portion of ridge cap needs replacing.

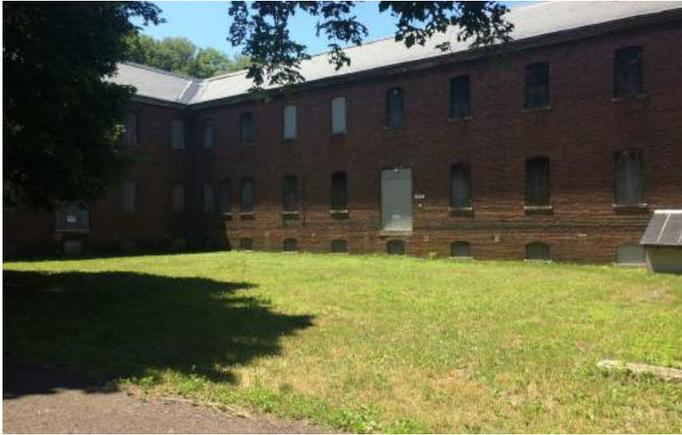
Courtyard E. side Building 36.

**Brick and stonework:** Significant cracking between windows & at NE. corner have been stabilized. Minor repointing needed.

**Roof and gutters:** Roof structure needs significant repair with several failed trusses temporarily supported. A large opening in E. side, N. end of W. wing has been covered with plywood. Damages truss in S. wing.

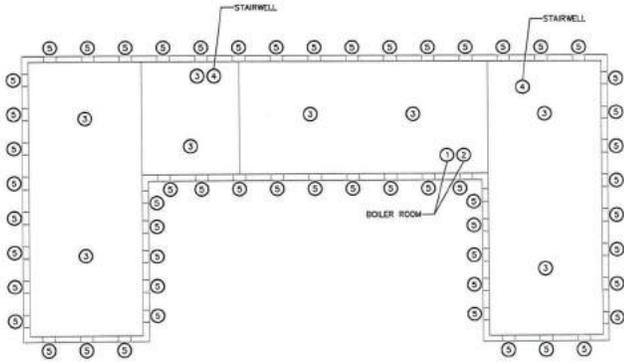
Basement level (at grade W. side).

①	FRIABLE THERMAL SYSTEM INSULATION (TSI) JACKET ASSOCIATED WITH BOILER	140 SF
②	FRIABLE PIPE INSULATION & MUDDIED FITTINGS ASSOCIATED WITH BOILER BREECHING	15 LF
③	FRIABLE PIPE INSULATION & ASSOCIATED MUDDIED FITTINGS	1,020 LF
④	WALL & CEILING PLASTER (FRIABLE)	16,275 SF
⑤	WINDOW & DOOR CAULK	ALL WINDOWS & DOORS
⑥	FRIABLE SURFACING MATERIAL AT INTERIOR WINDOW APRONS (INCLUDES CONCEALED AREAS BEHIND WALLS)	MOST WINDOWS AT 1ST AND 2ND FLOORS

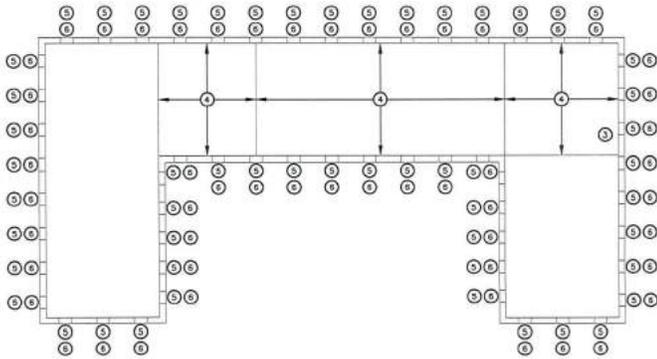
First floor ( raised above grade).

①	FRIABLE THERMAL SYSTEM INSULATION (TSI) JACKET ASSOCIATED WITH BOILER	140 SF
②	FRIABLE PIPE INSULATION & MUDDIED FITTINGS ASSOCIATED WITH BOILER BREECHING	15 LF
③	FRIABLE PIPE INSULATION & ASSOCIATED MUDDIED FITTINGS	1,020 LF
④	WALL & CEILING PLASTER (FRIABLE)	16,275 SF
⑤	WINDOW & DOOR CAULK	ALL WINDOWS & DOORS
⑥	FRIABLE SURFACING MATERIAL AT INTERIOR WINDOW APRONS (INCLUDES CONCEALED AREAS BEHIND WALLS)	MOST WINDOWS AT 1ST AND 2ND FLOORS

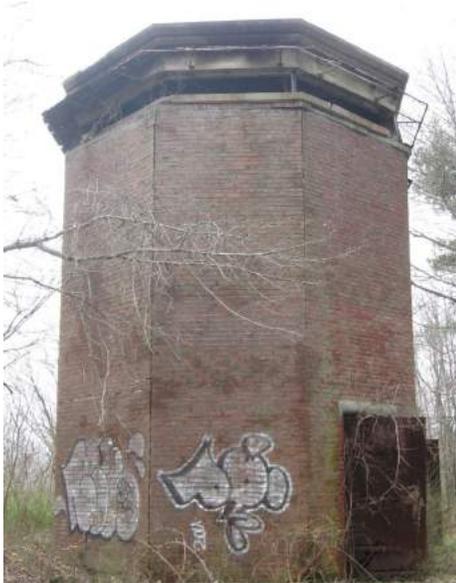
Fire Control Tower N. elevation.

**Roof and gutters:** Corrosion has dislocated the observation area roof slab.

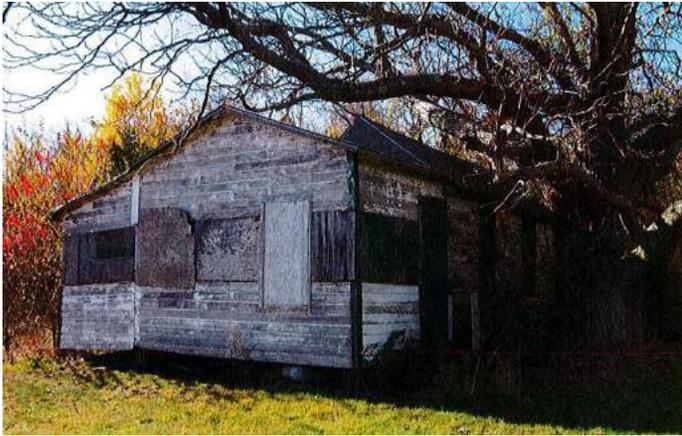
Cottage 06 from NE..

**Structural stability:** Some portions stable. The wood foundation piers are insufficient to support the structure and may be causing the sag to the main roofline.

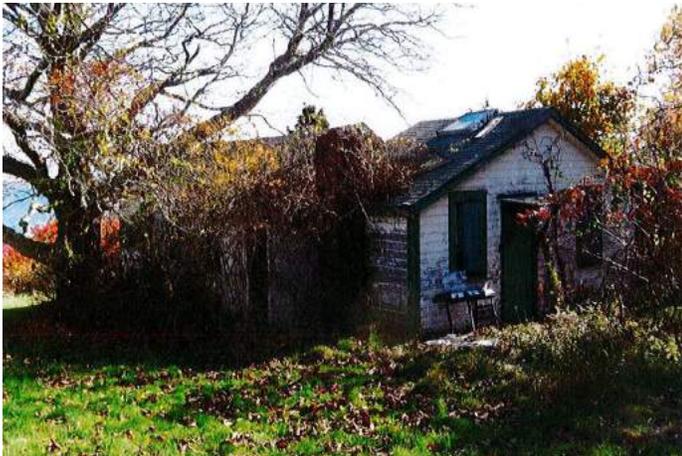
Cottage 06 from SW..

**State of interior:** Interior not accessible. There is likely water damage as a result of the collapsed W. roof.

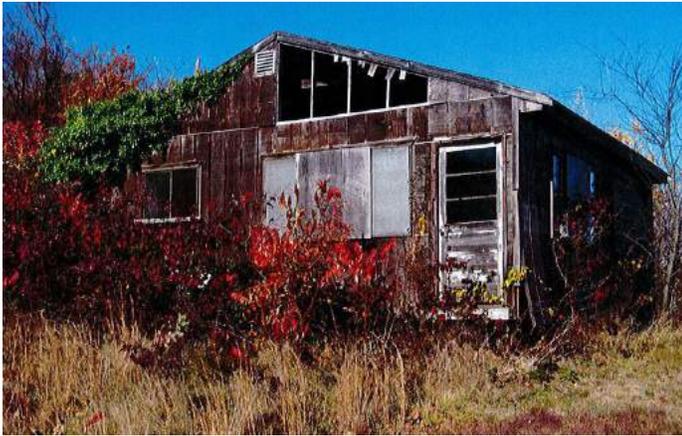
S. elevation of Cottage 09.

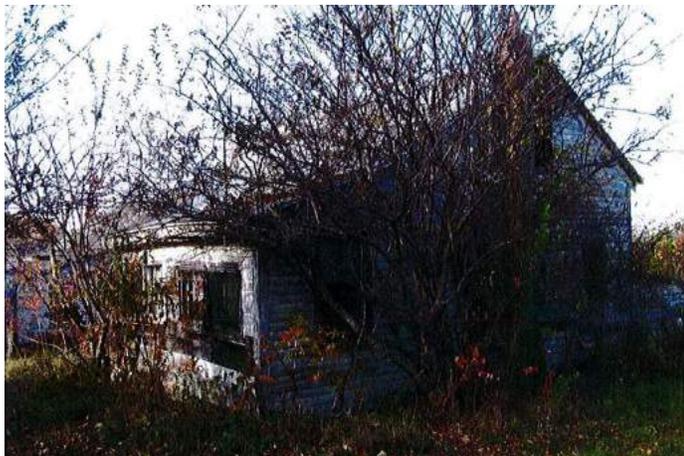
**Status:** Main structure is stable. Front porch collapsed

View of Cottage 21 from SE.

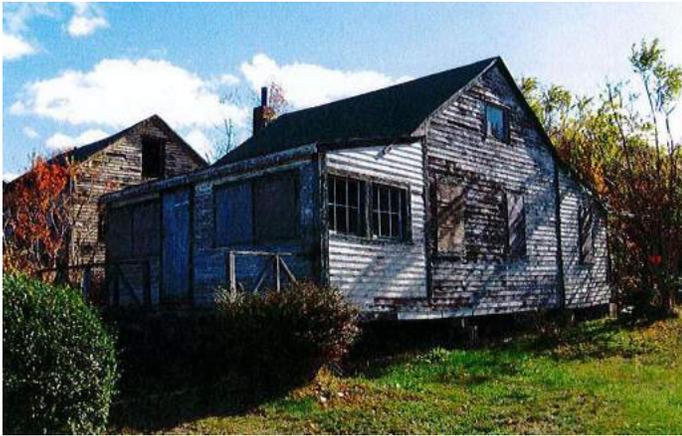
Cottage 22 from NW.

**Structural stability:** Main structure stable. Rear porch in poor condition. Foundation piers need attention.

**Foundation:** Wooden and concrete piers may need replacing. Metal jacks are rusting and should be replaced with permanent treated supports.

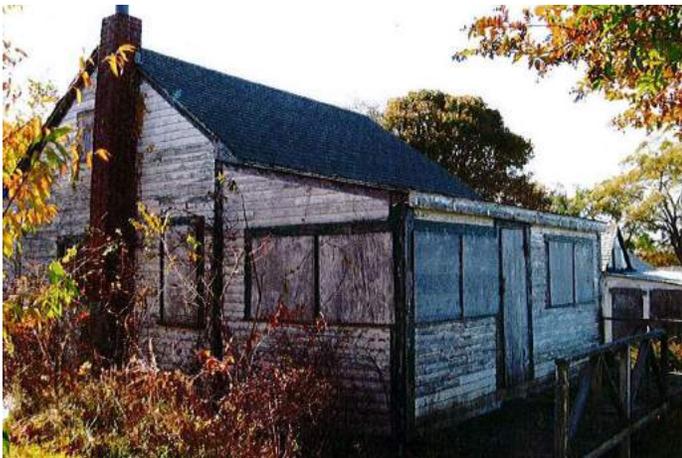
Enclosed porch of Cottage 22.

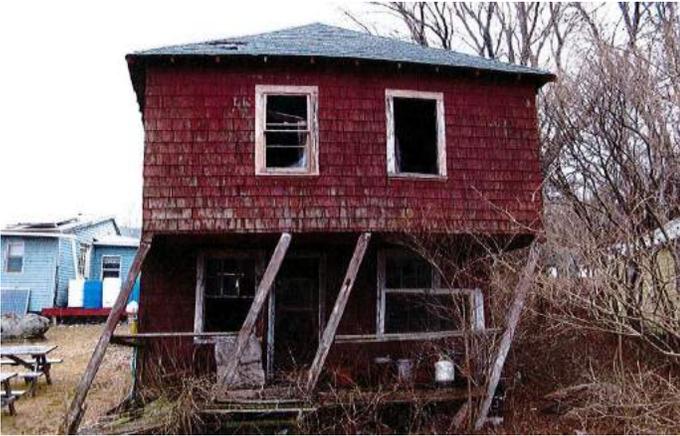
W. Overhang & porch, Cottage 28.

**Structural stability:** Unstable condition. The roof is deflecting, support piers and sills are rotten or collapsed. The supporting columns for the second floor are severely splayed.

**Foundation:** Visible support pier has collapsed causing cracking to the walls. Sills are likely rotting in places.

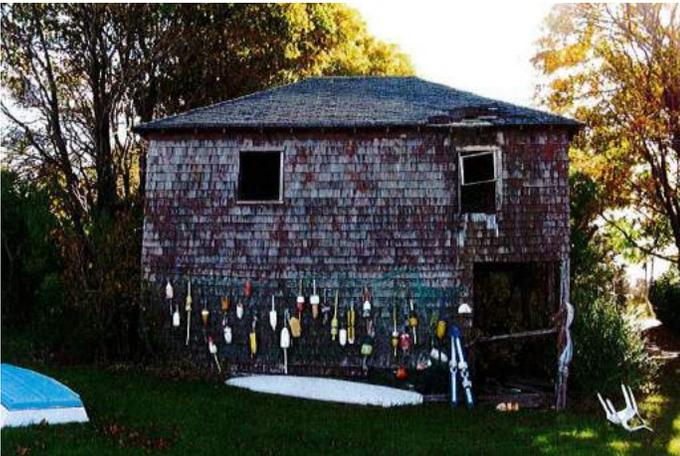
Cottage 28 from N.

**Roof and gutters:** Roofing is deteriorated and missing in places causing damage to plywood below.

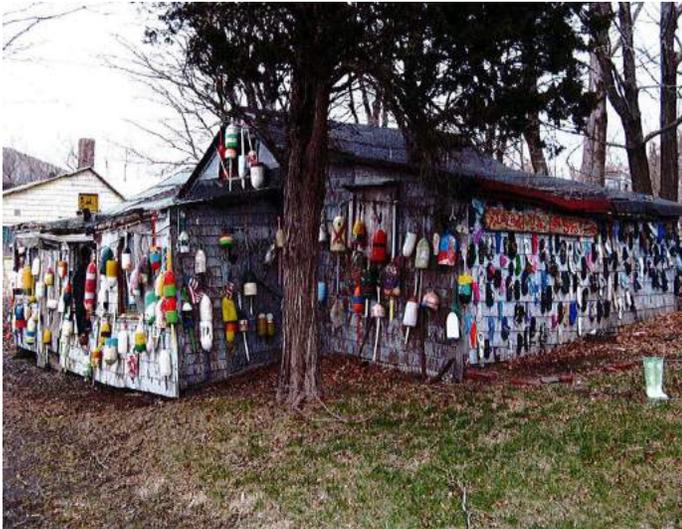
Cottage 30 from SW.

**Foundation:** Wooden piers and sills are below grade causing significant rot.

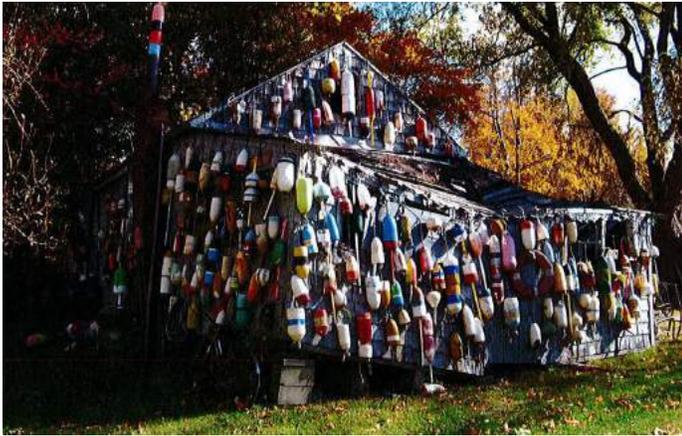
W. elevation Cottage 32 showing buoy decoration.

**Structural stability:** Sills and beams show significant rot. The roof is failing and deflecting. The front porch piers have failed and the structure is sagging.

**Foundation:** Concrete block footings have collapsed under the front porch and require reinforcement.

**Roof and gutters:** The roof is sagging heavily. Deteriorated shingles have allowed damage to sheathing..

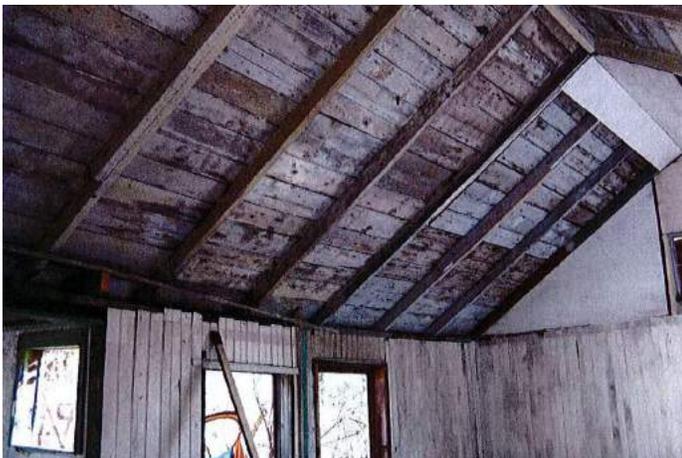
Interior of Cottage 38.

**State of interior:** Interior in sound condition apart from front porch area.

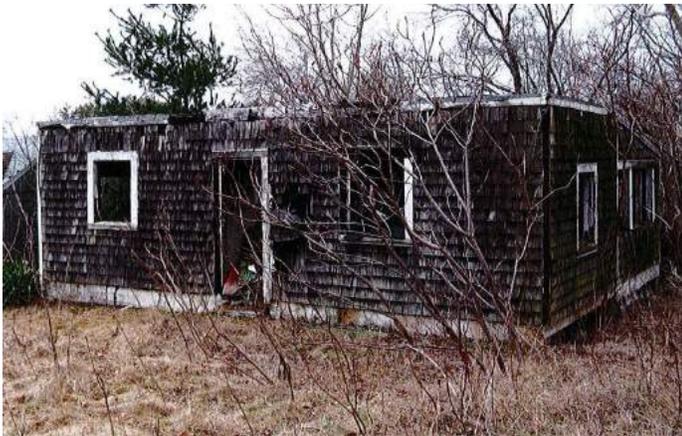
Cottage 39 entrance from NE.

**Structural stability:** Primary framing intact but floor joists, flooring and rafts have extreme rot.

**Roof and gutters:** The main roof structure has completely collapsed. The front porch roof has rotted through causing rot to remaining rafters.

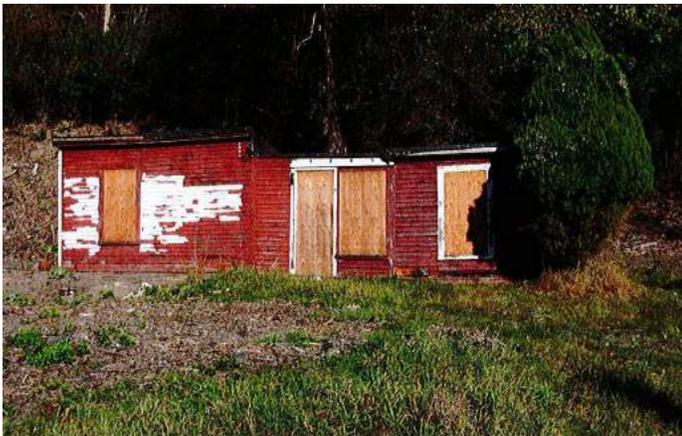
West facade, Cottage 45

**Foundation:** Foundation inaccessible for inspection. Some signs of settling but appears sound overall.

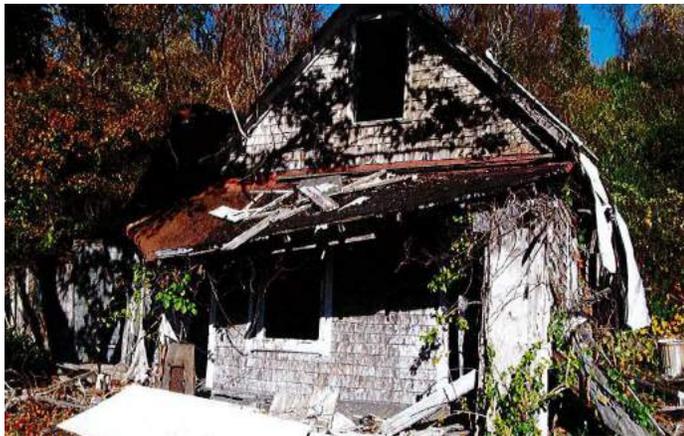
Enclosed entry porch W. elevation of Cottage 46.

**State of interior:** Interior in poor condition due to water ingress from missing roofing.
